Postgraduate Dissertation

“Integrated Assessment of Climate-Induced Risks and  
Preservation Strategies for the Temple of Apollo at Ancient  
Corinth.”

M.Sc. Protection of Cultural Heritage and Monuments  
of Nature from the Effects of Climate Change

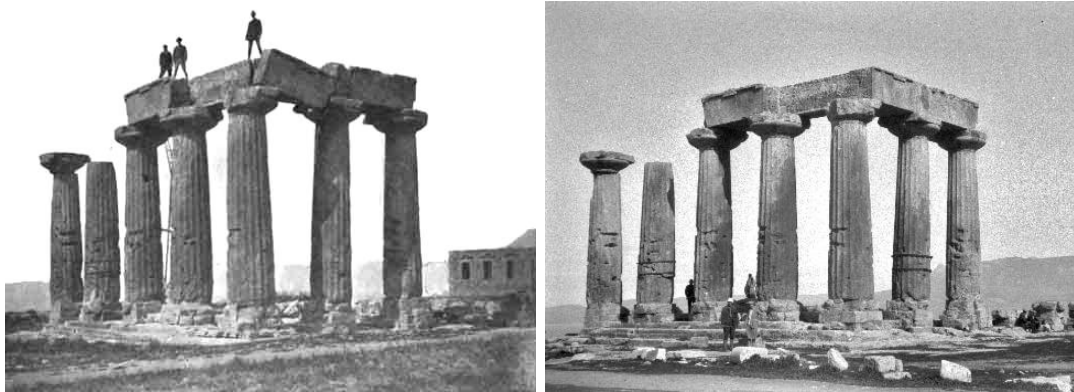
**Figure 8.** Temple of Apollo at Ancient Corinth: (a) condition before the 1908 restoration; (b) condition after restoration.

The initial documented conservation intervention took place in 1908, when a fractured epistyle block at the preserved western end of the temple was stabilized. The condition of the monument has been documented through archival photographs both before and after the initial intervention (Scahill, 2017).

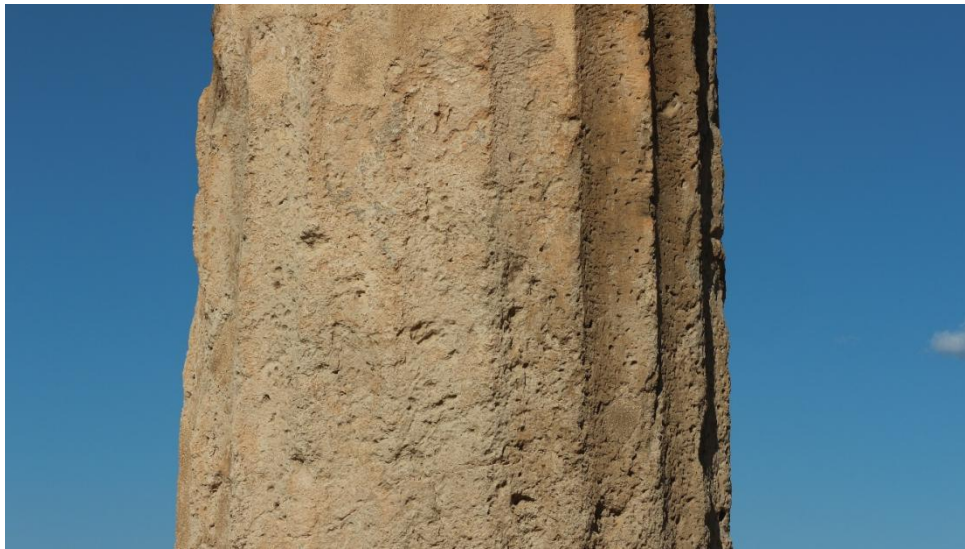
**Figure 15.** Granular disintegration visible on a column.

One of the most characteristic deterioration patterns observed is **granular disintegration**, where individual grains detach from the stone surface, leading to a gradual loss of cohesion. This phenomenon is particularly evident on the shafts of the columns, where rough, irregular surfaces and clear degradation of the original morphological finish can be observed.

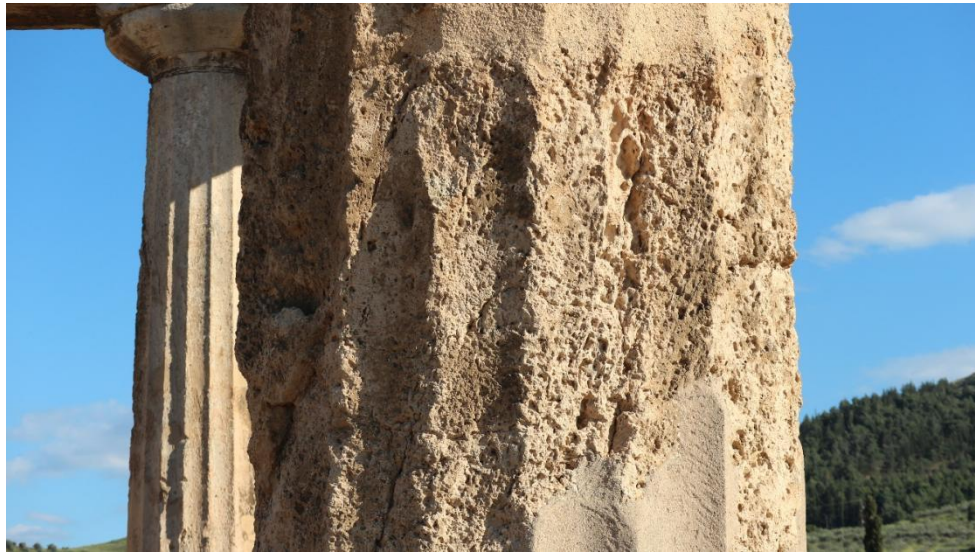
**Figure 17.** Alveolization on an exposed column surface, showing the development of cavities associated with localized material loss.

corresponds to progressive localized material loss through the development of interconnected cavities, indicating advanced disintegration of the porous stone.

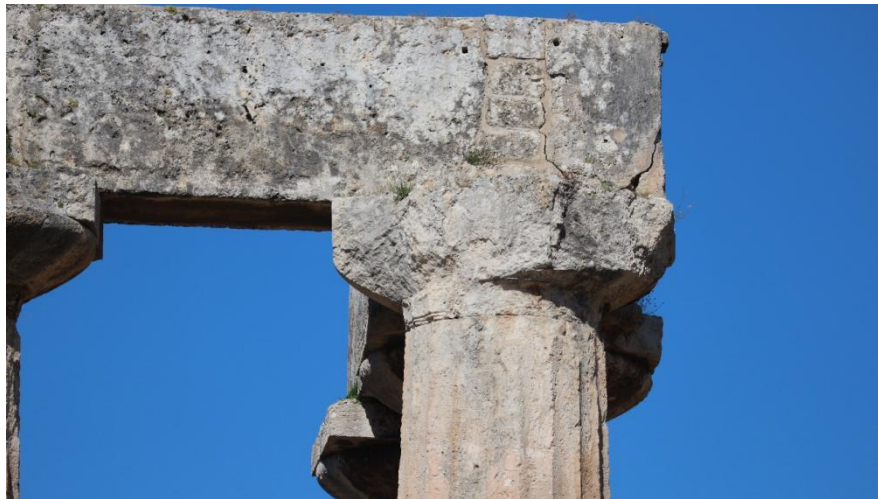
**Figure 20.** Localized cracking and fracturing affecting an upper structural element.

Localized **cracking** and **fracturing** are also evident, primarily in upper structural members and connection points. These discontinuities are of particular concern, as they provide pathways for the ingress of moisture and soluble salts into the stone matrix, thereby promoting and accelerating further deterioration processes.

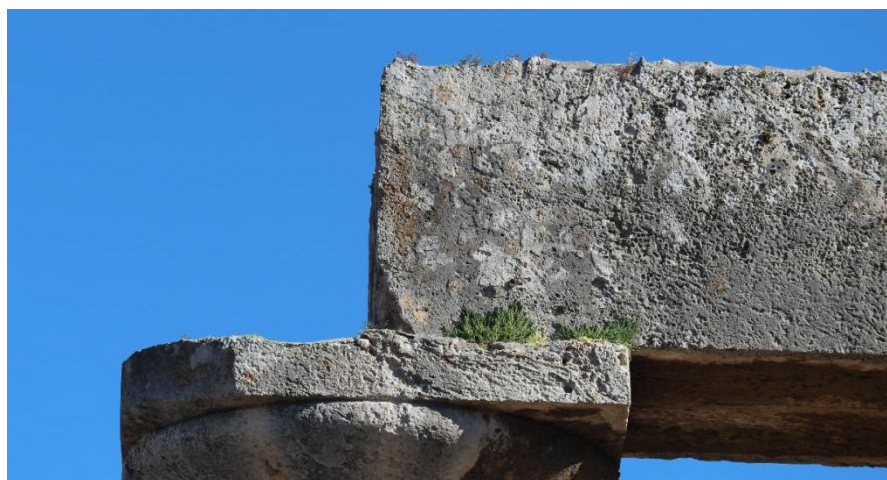
**Figure 21.** Biological colonization on the stone surface, particularly within joints and moisture-retaining areas.

**Biological colonization** was also observed, particularly in joints and horizontal surfaces where moisture is retained. It appears that biological growth is more pronounced in the peripheral remains of the temple. Such biological activity may further contribute to material deterioration through mechanical pressure and localized chemical alteration.

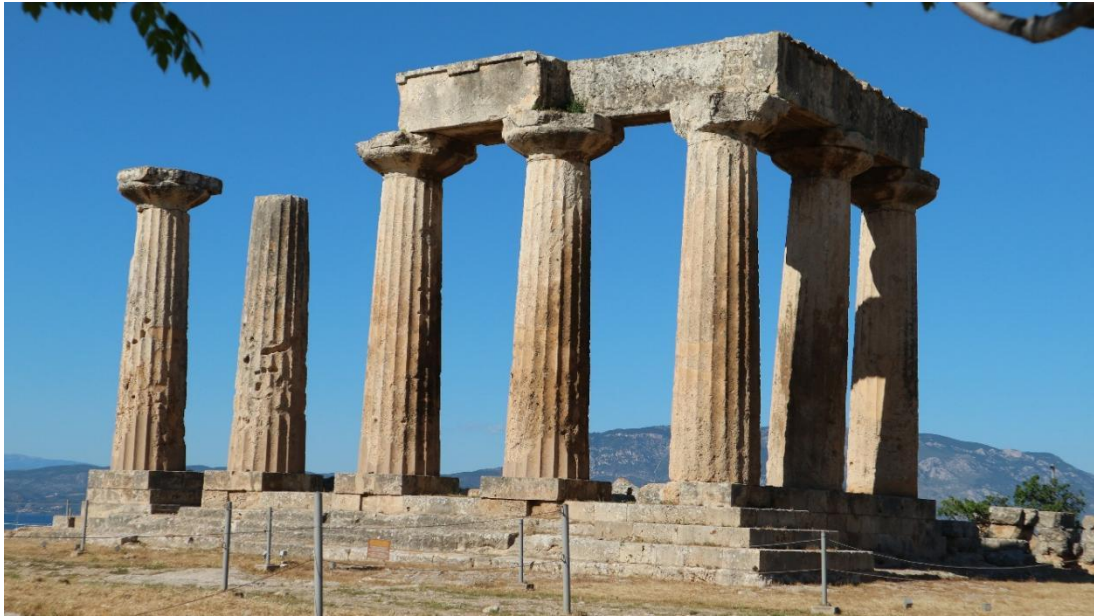
**Figure 24.** Apparent outward inclination of the columns on the three-column side of the Temple of Apollo.

continuous transfer of compressive loads through contact. In addition, cracks or openings at connection points may act as stress concentration zones and contribute to local instability.

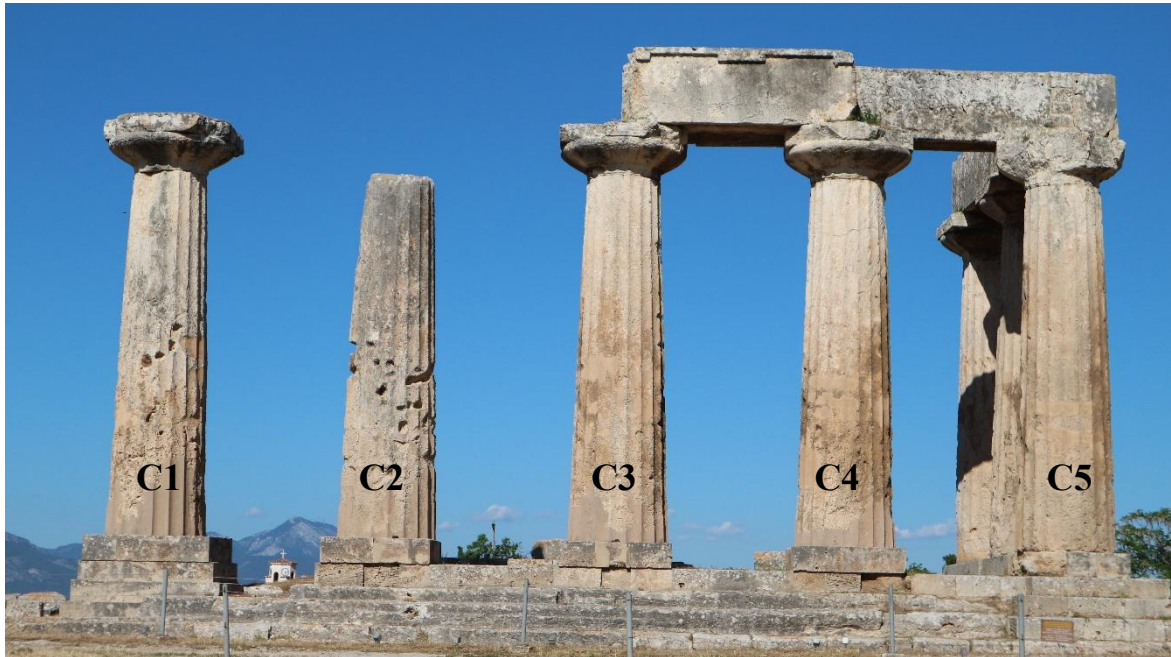
**Figure A.1.** Overall condition of Columns C1–C5, front elevation.

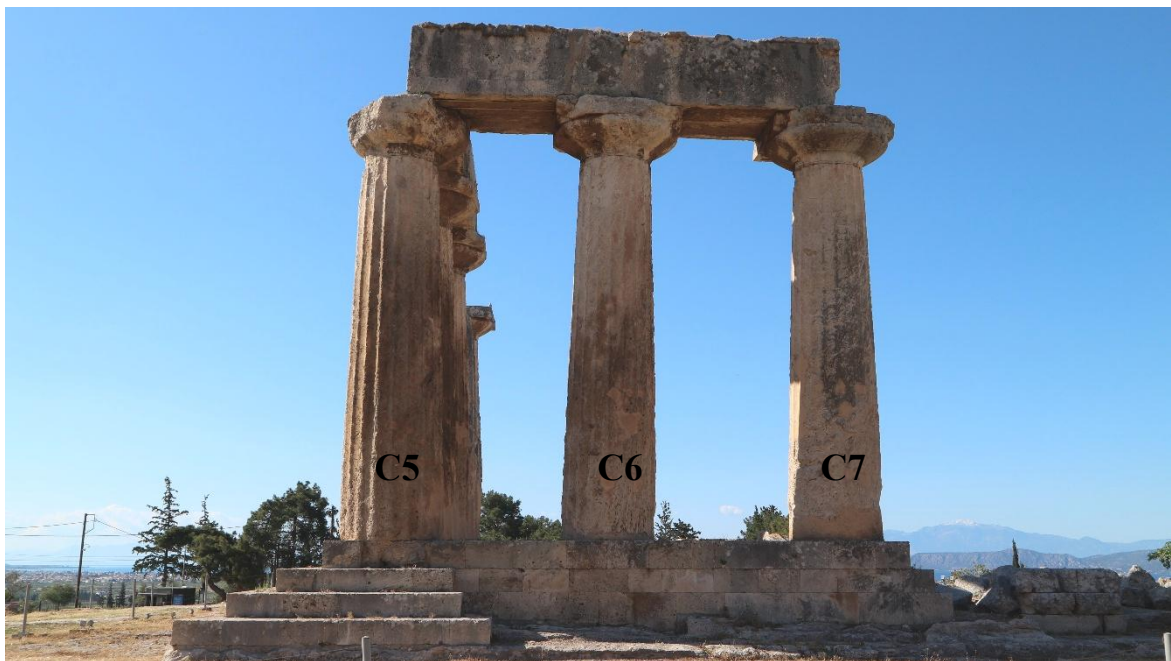
**Figure A.2.** Overall condition of Columns C5–C7.

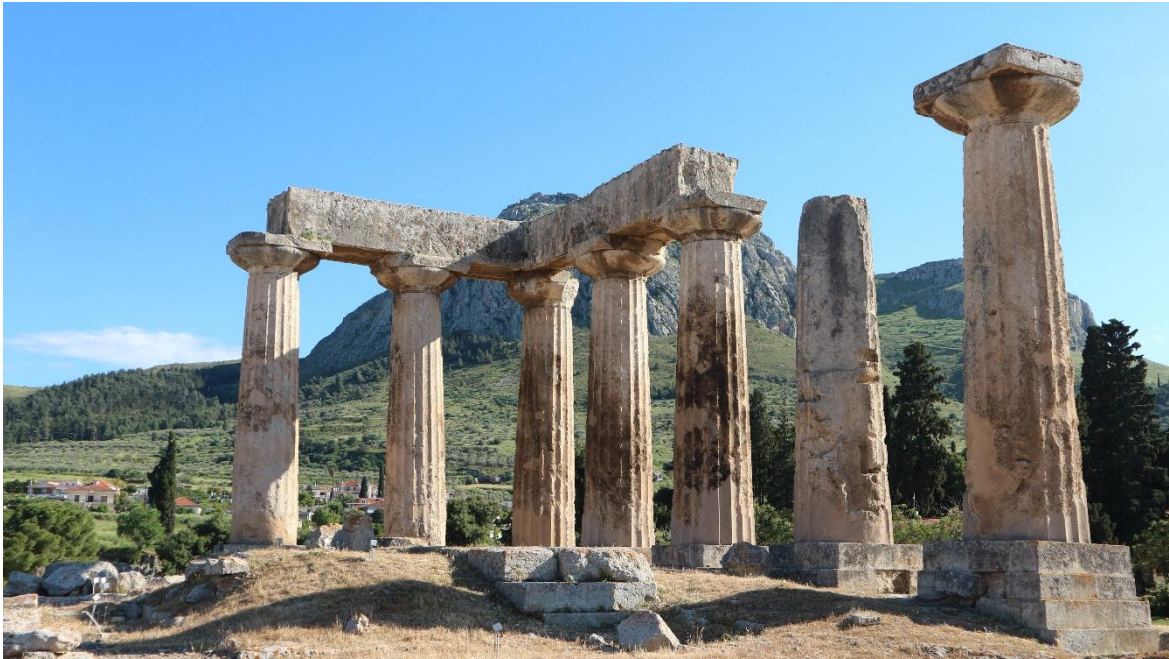
**Figure A.3.** Overall condition of the surviving columns and architrave, viewed from the interior.

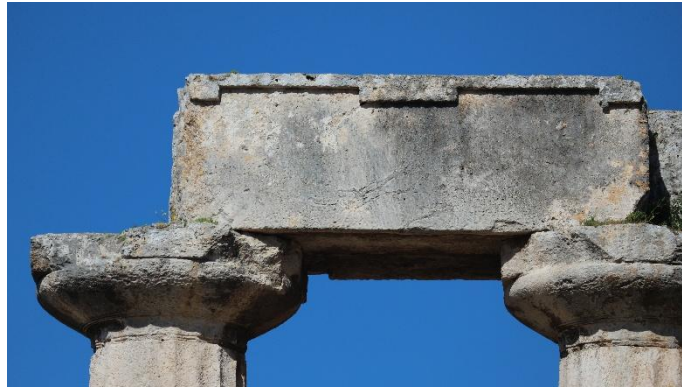
**Figure A.4-6.** General condition of the architrave and adjacent Doric capitals.

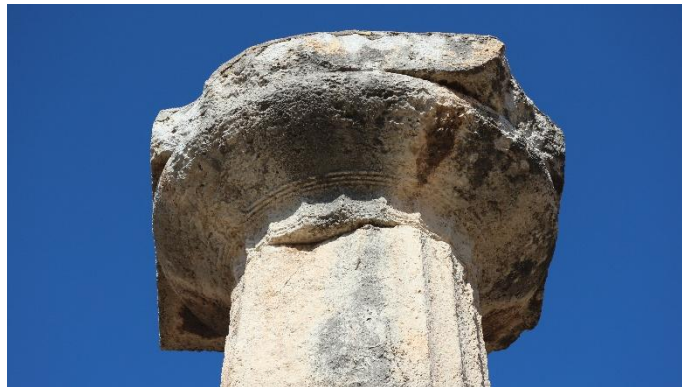
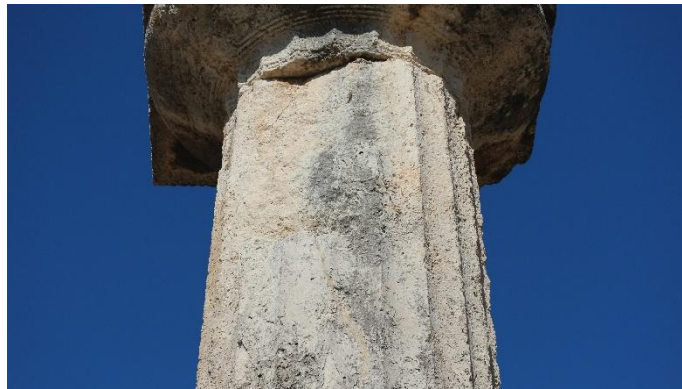
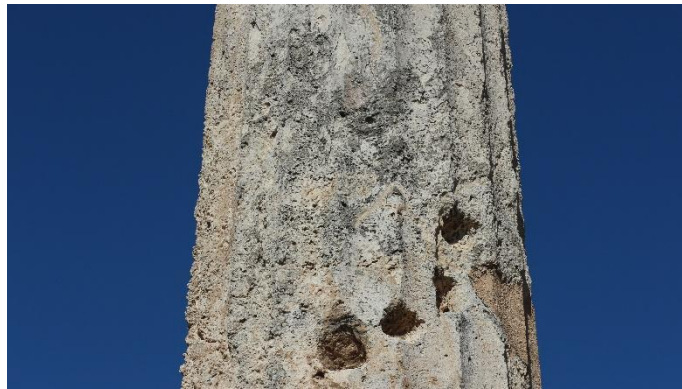
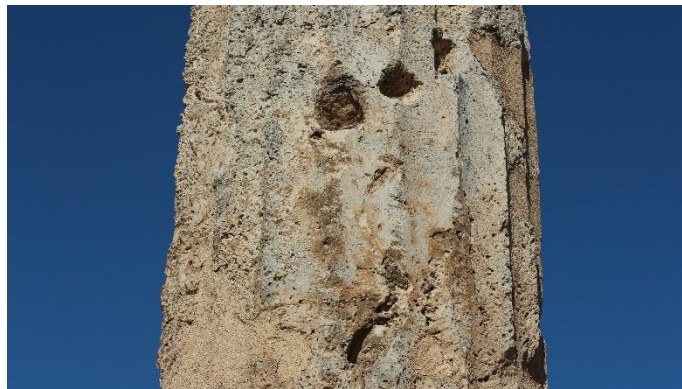
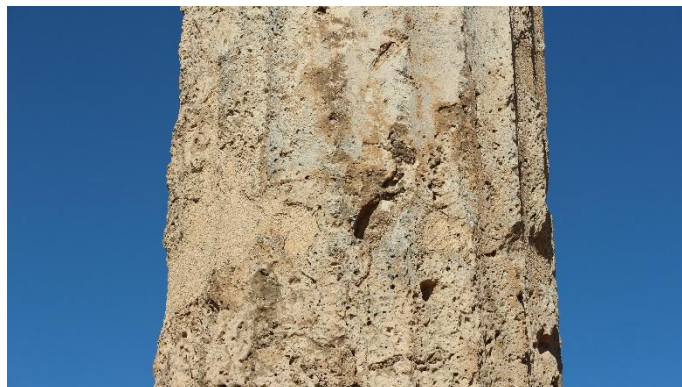
**Figure A.7-14.** State of preservation of Column 1 (C1), front elevation.

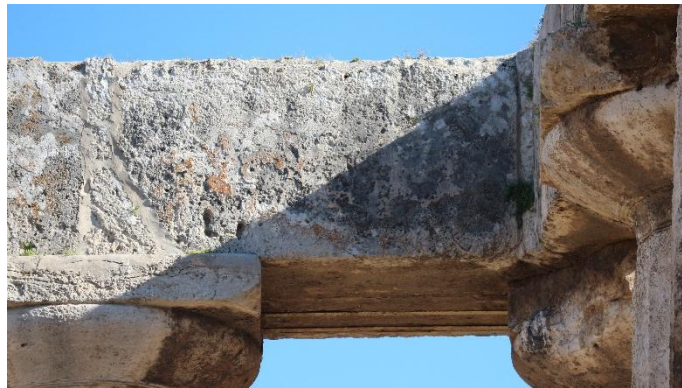
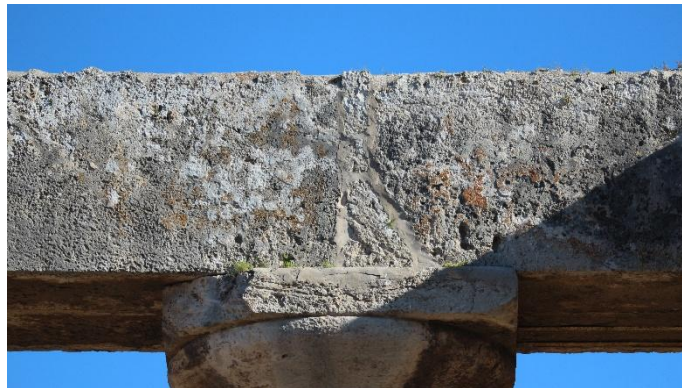
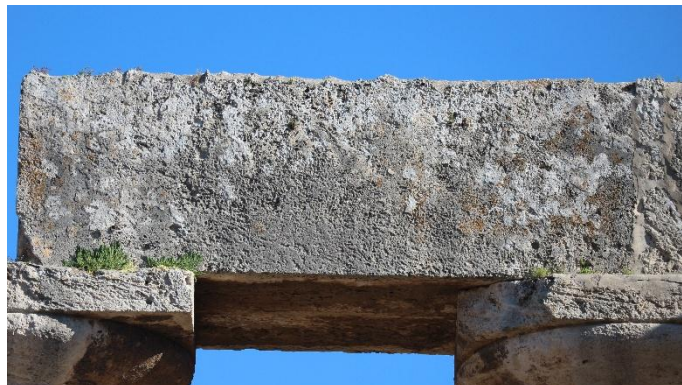
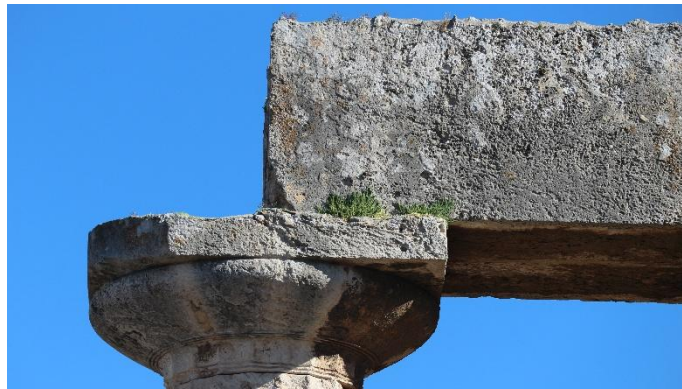
**Figure A.82-85.** General condition of the architrave and adjacent Doric capitals, viewed from the interior.

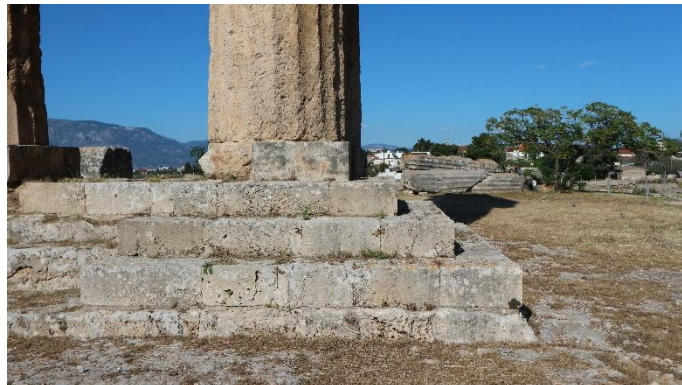
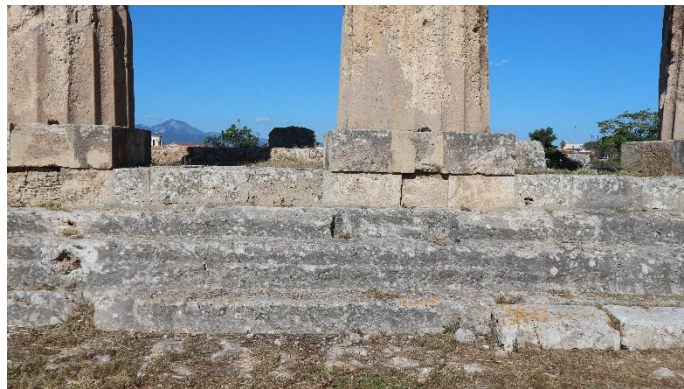
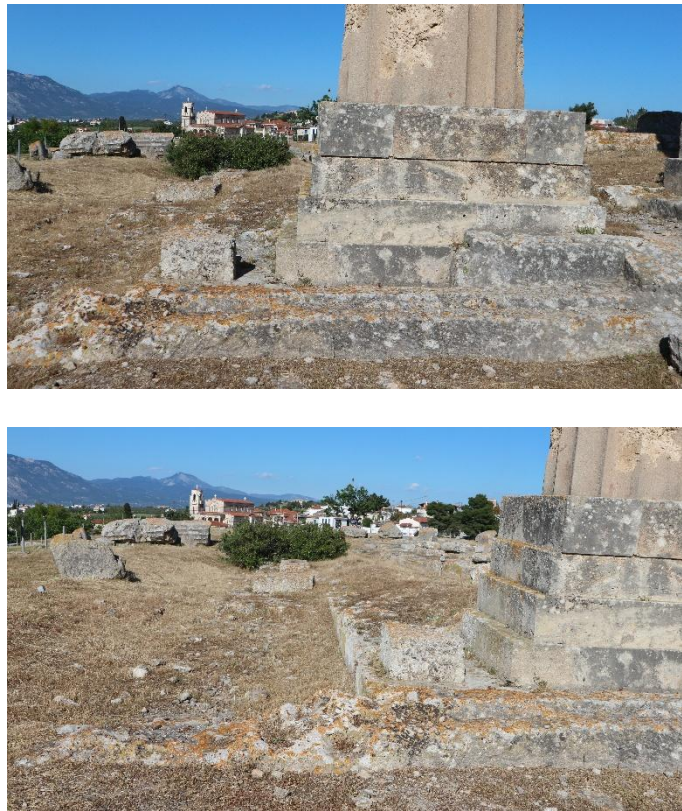
**Figure A.86-94.** General condition of the stepped foundation platform (krepidoma).
