Postgraduate Dissertation

«Hagia Sophia in urgent need of protection from the effects of  
seismic activity»

Maria Karkali

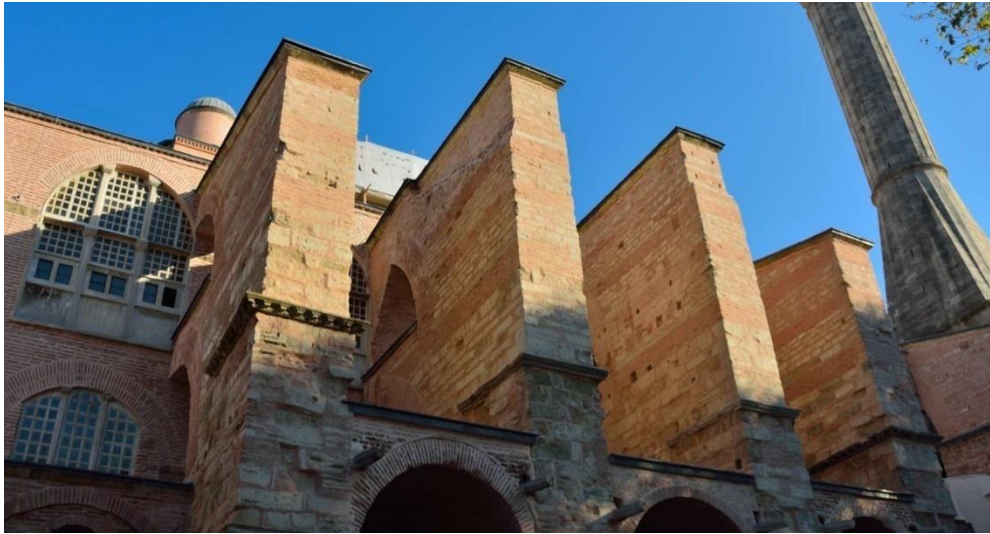
*Figure 5. Buttresses Source: HagiaSophiaturkey.com*

The four massive internal stone and granite piers, some added in different periods in history to prevent walls from buckling under lateral weight.

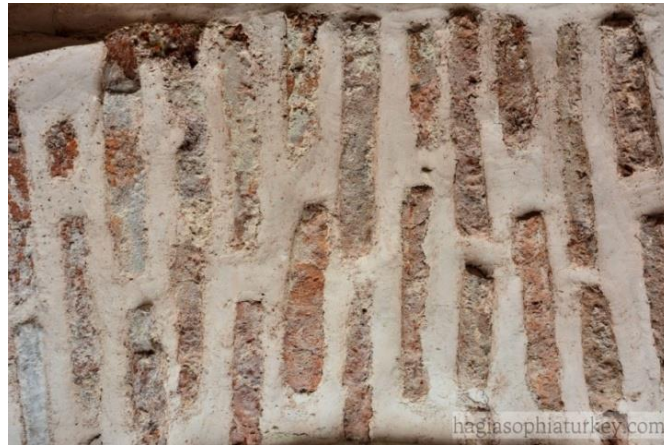
- **Masonry mortar:** The original Byzantine mortar was made from lime, crushed brick and a volcanic ash, known as pozzolana. This mixture is classified as an advanced cement-based composite material. This could explain why the structure has lasted so long. The mortar joints in the Hagia Sophia are notably thicker than the bricks themselves. This enables the walls and arches to absorb and redistribute stresses, providing strength and durability. This combination of materials is characterized by a very long curing period (Moropoulou A. et al., 2006). This is a significant factor in the building's seismic resistance, given that Istanbul is one of the most seismically active cities in the world.

Figure 6. Masonry detail with exposed thin bricks and integrated thick mortar joints

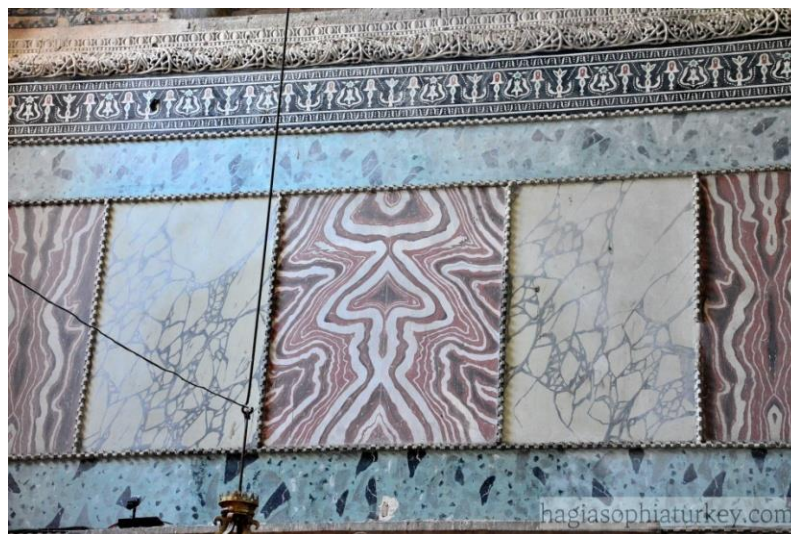
Figure 7. Colored and decorative stones in Hagia Sophia

- Marble, was used for the interior decoration of Hagia Sophia. Imported from across the Byzantine Empire, the costly colored marble and ornamental stone inlays were taken from ancient buildings and reused to support the interior arcades. Key marble materials included green columns from the Temple of Artemis in Ephesus, Celtic marble from France and white marble from Marmara (Tribe, 2025). Procopius says, “...Who could recount the beauty of the columns and the stones with which the church is adorned? One might imagine that he had come upon a meadow with its flowers in full bloom....”(Hagia Sophia, n.b.).

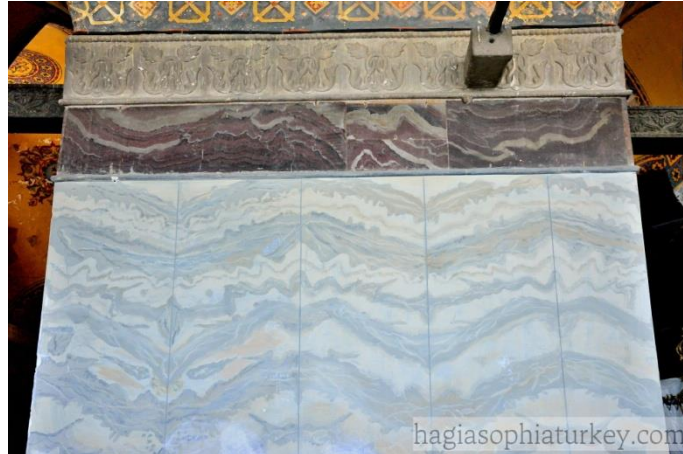
Figure 11. Light-colored sections of Proconnesian marble). Source [hagiasophiaturkey.com](http://hagiasophiaturkey.com)

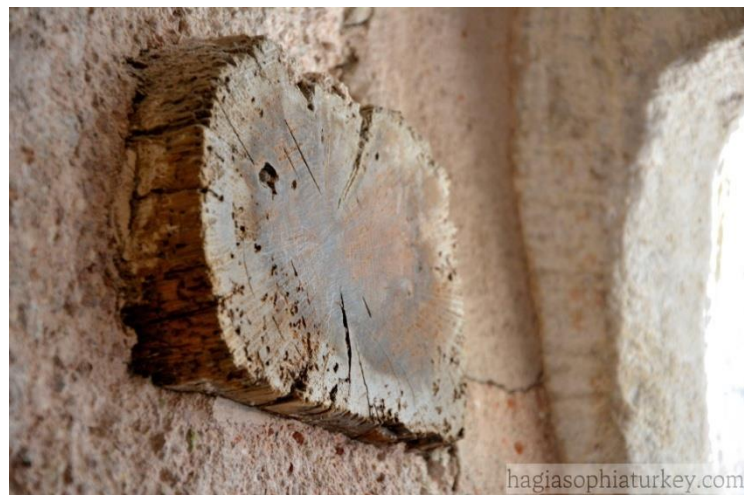
- Although timber was not the primary material used, it was very important during the construction process. It was used for scaffolding and to provide temporary support. It was also used to support arches and vaults while they were being built. Despite its importance, timber was still mostly used temporarily. However, legend has it that the Imperial Door in Hagia Sophia was made from no ordinary timber, but from Noah's Ark itself. This majestic door, which stands at around seven meters tall, was built using oak timbers (The editors of the Madain Project, n.d.). The original wooden roof was later replaced with lead sheets.

*Figure 12. Cross section of a wooden log embedded horizontally in a textured*  
*Source: hagiasophiatrueky.com*

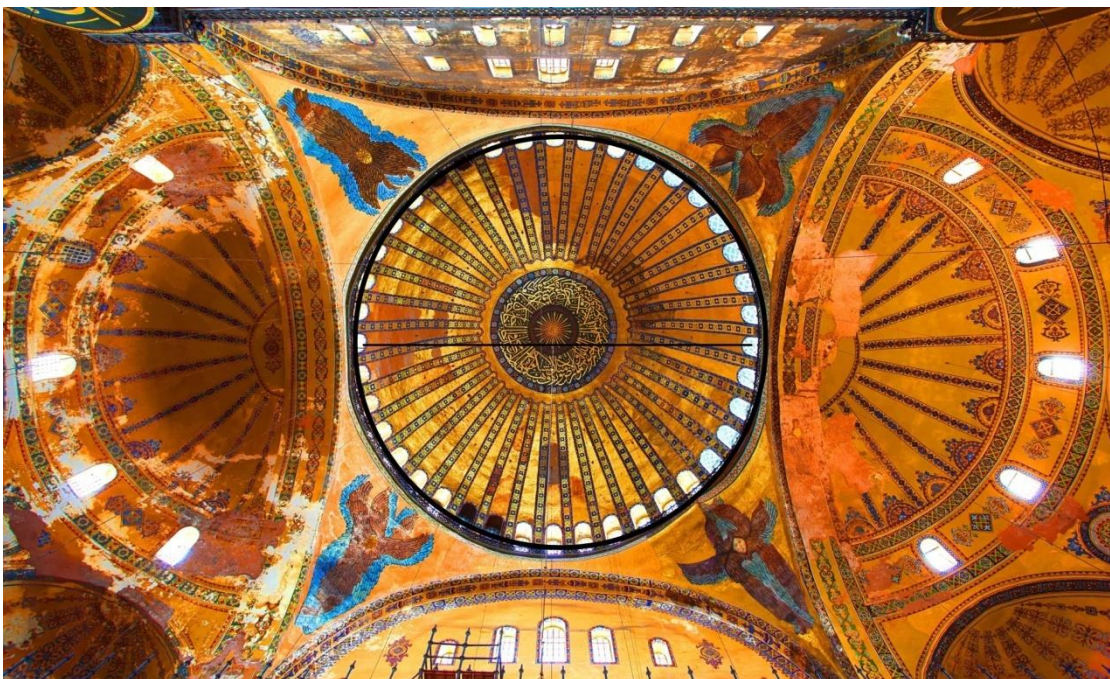
For many years, patterns of damage resulting from seismic activity have been observed, focusing on specific structural weakness inherent in the ambitious architecture of Hagia Sophia. Lateral forces were strongly transmitted to the supporting walls, causing displacement. Subsequently, in 558, the dome collapsed completely due to earlier earthquakes. The dome was then rebuilt with a higher crown and a series of ribs to ensure that forces were distributed directly to the structural supports (Savage, 2026). However, powerful earthquakes caused partial collapses of the dome during the 10<sup>th</sup> and 14<sup>th</sup> centuries. Even today, after enduring years of seismic stress, the dome is no longer perfectly circular, but appears more elliptical.

*Figure 22. The dome. Source: Theothertour August 2026, Edited by Maria Karkali*

The central dome collapsed in 558, and was subsequently rebuilt in 989 and again in 1346. Although the dome has remained intact since then, past reconstruction efforts resulted in the construction of four asymmetrical arches. According to Dikes, these arches are thinner than optimal, making the dome more fragile (Sevencan, 2025).

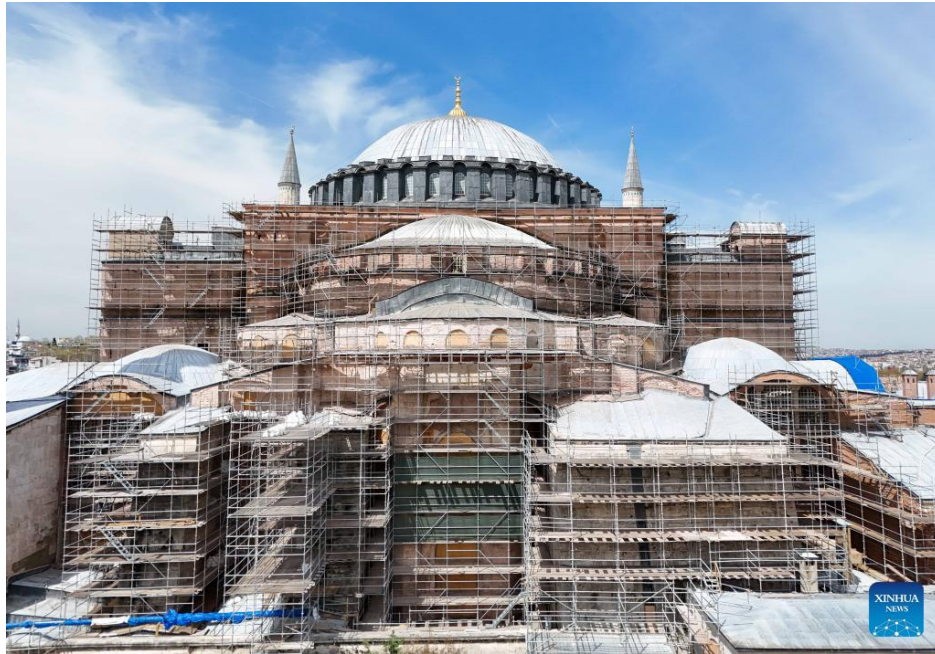
According to the architect Hasan Firat Diker, “*The main dome is completely covered on the outside. We will continue this process in the eastern half-dome and observe the interventions that need to be made*”.

Figure 24. Photo taken on April 14, 2025 shows Hagia Sophia under restoration in Istanbul, Türkiye. Türkiye on Monday started the first-ever comprehensive restoration work on the main dome of Hagia Sophia, one of the most important historical sites in Istanbul. (Xinhua/Liu Lei)

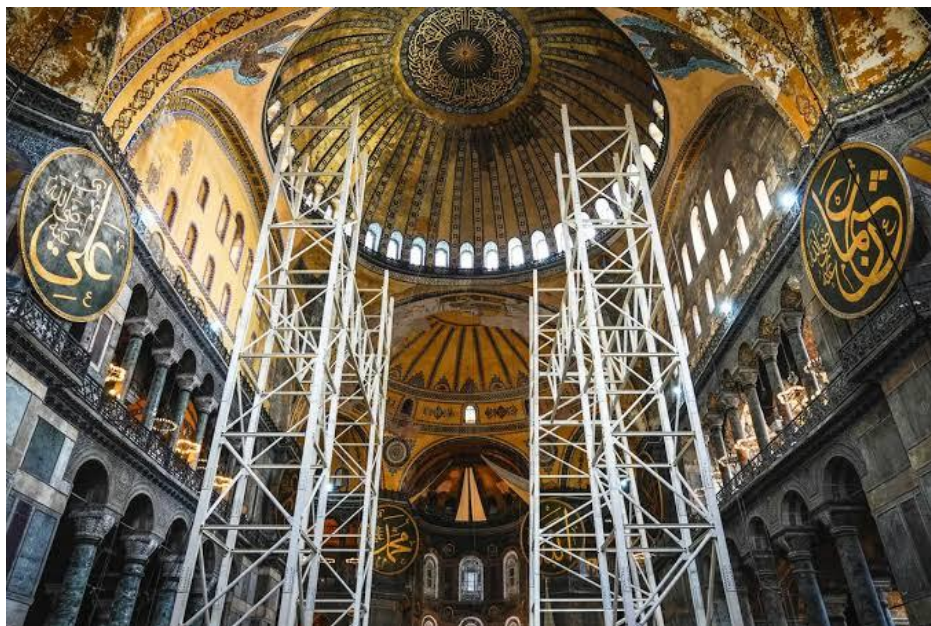
Figure 25. Construction techniques Source: Hispanatolia.com

A multi-layered temporary flooring system was installed in all areas through which construction machinery was to pass. This ensured both load distribution and protection of the marble slabs. To prevent damage to the original marble flooring, a complete protective system comprising the following layers was applied:

- A vapor-permeable membrane
- Felt
- Sand
- 18mm plywood
- A 10 x 10 cm wooden frame
- XPS insulations boards placed between the frames
- A sound-absorbing underlay on top
- Finally, a diamond-patterned steel sheet is placed on top (Republic of Turkey/Ministry of Culture and Tourism)

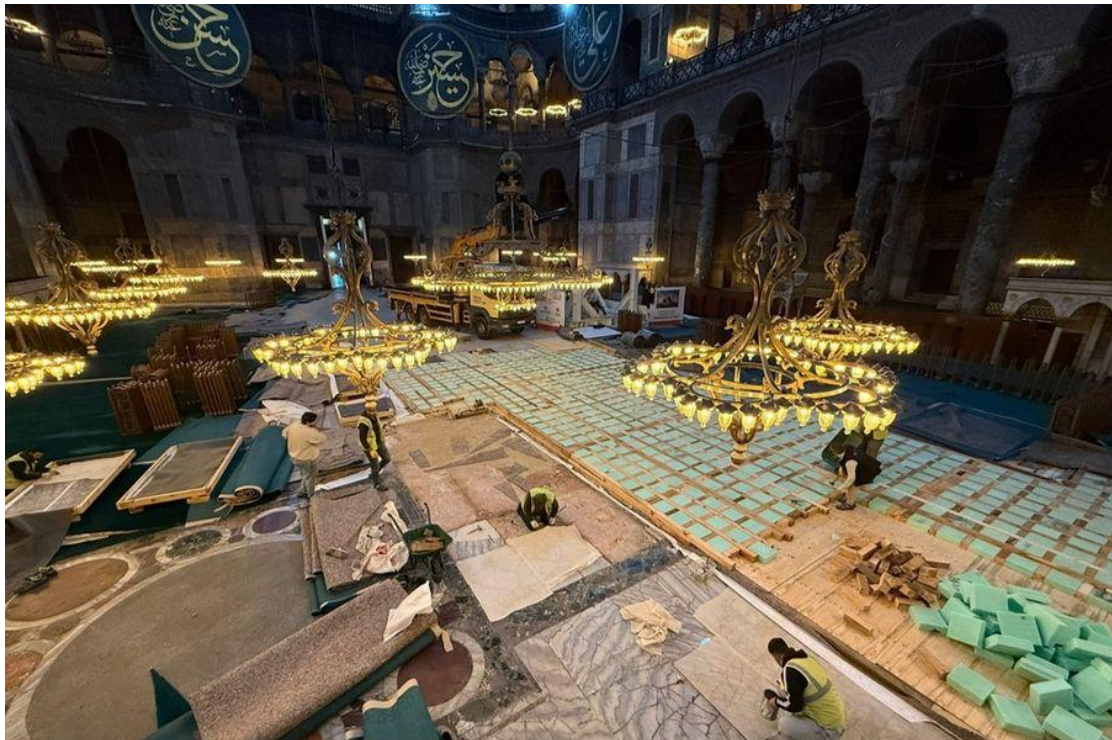
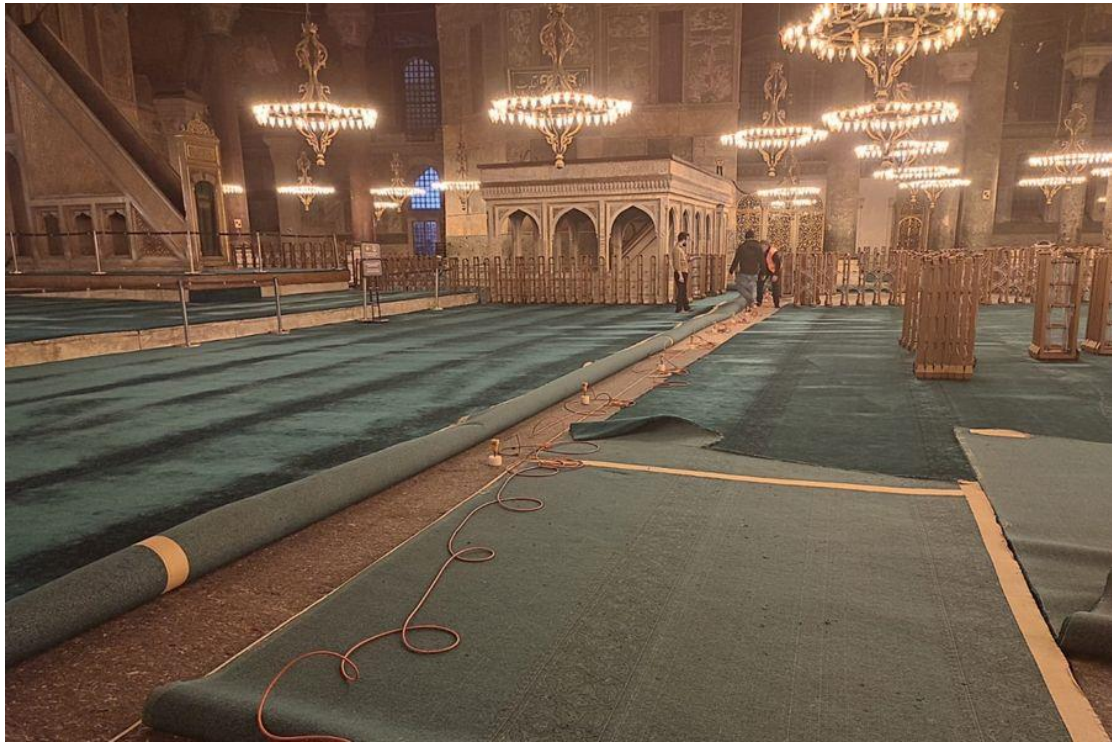
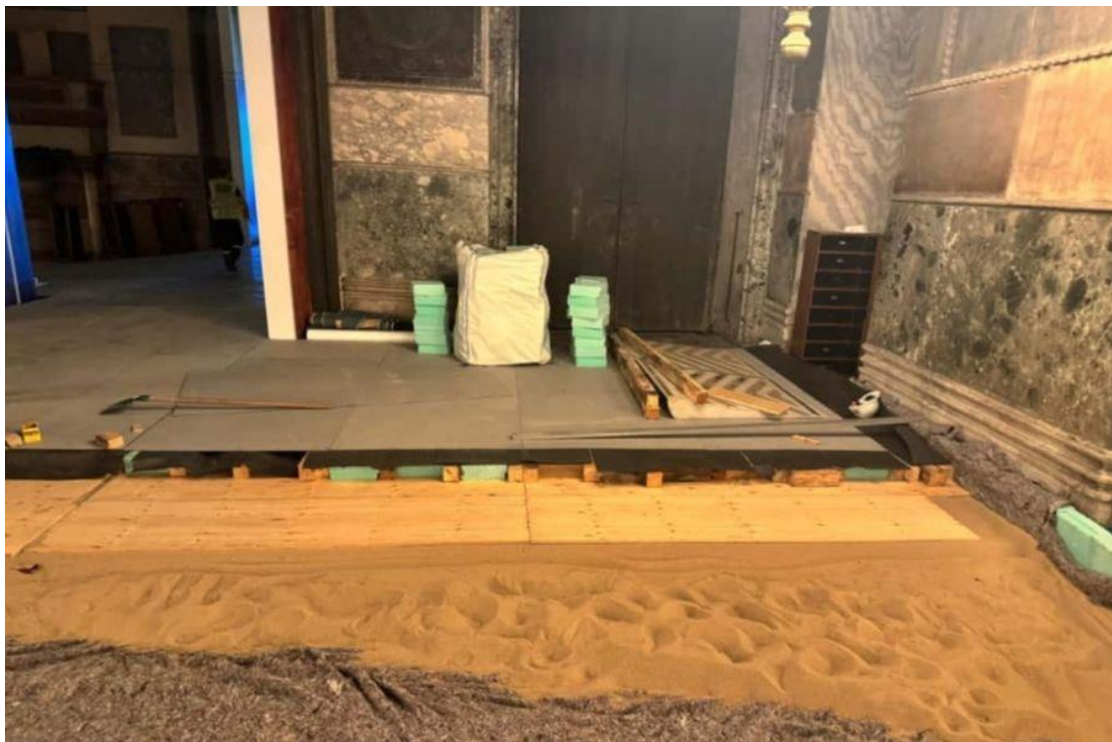
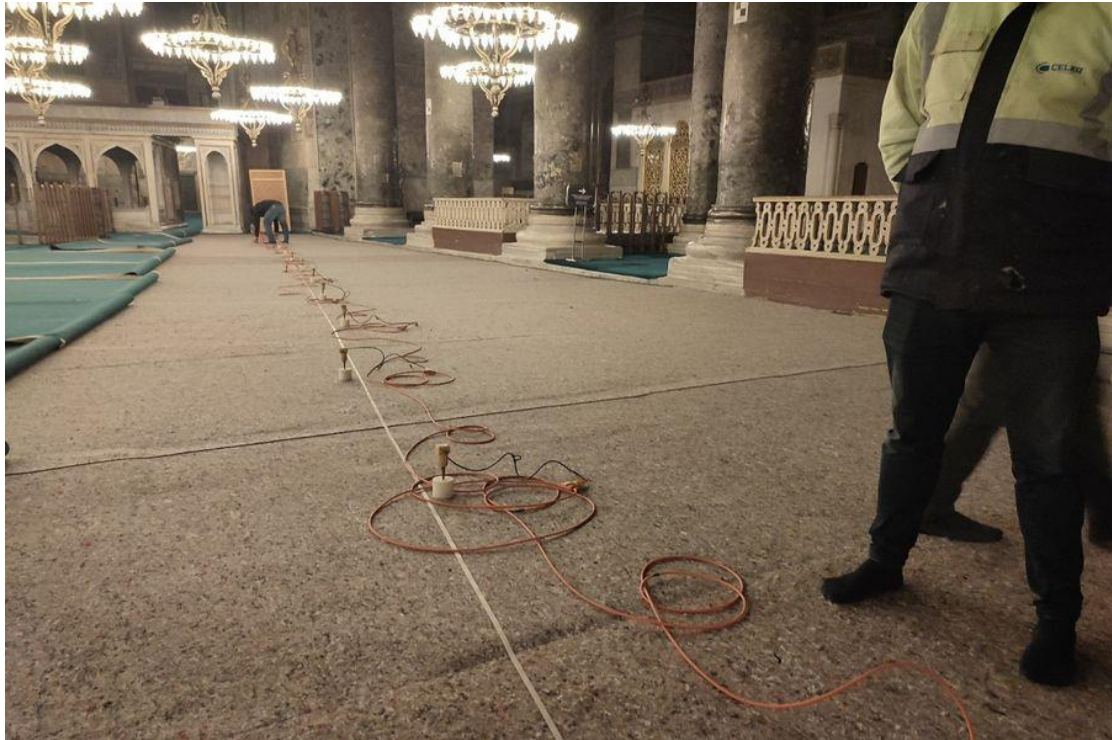
*Figure 26. Ongoing works at the Hagia Sophia Grand Mosque continue under the decisions of the scientific committee and the conservation board. Source: Republic of Turkey, Ministry of Culture and Tourism*

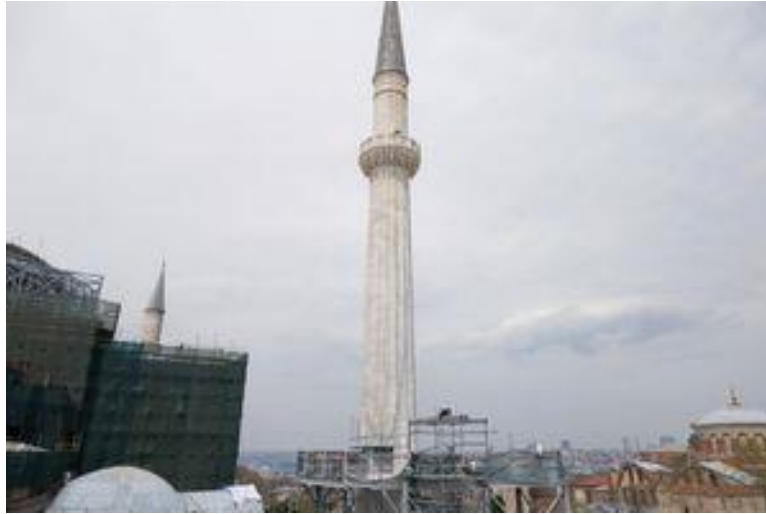
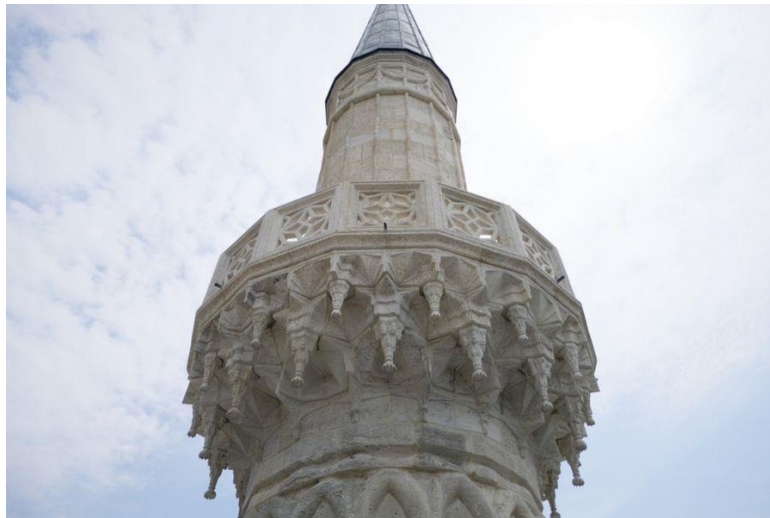
Instead of replacing everything with modern materials, damaged masonry and structural components are repaired using carefully selected compatible materials. A priority was the northeast minaret of Hagia Sophia. In April 2026, the Turkish Ministry of Culture officially announced the completion of the restoration work on the minaret. In line with the Scientific Committee’s decision, the upper sections, were partially dismantled and reconstructed, while the lower sections were strengthened. During this process, 411 stones and 26 rows of steps were carefully dismantled and categorized.

*Figure 30 Minaret of Hagia Sophia. Source: tgrthaber.com*

*Figure 31 Minaret of Hagia Sophia. Source: tgrthaber.co*

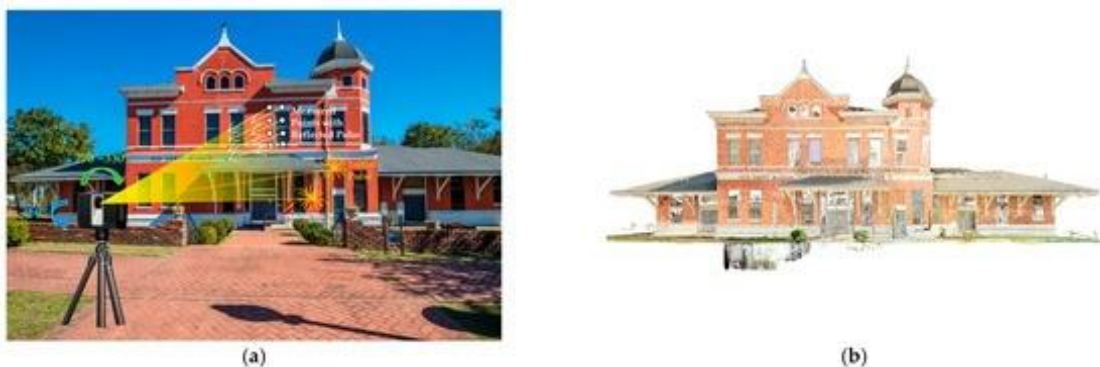
At Hagia Sophia, TLS is used to precisely document the central dome, the semi-domes, arches and piers. It can also detect minor deviations from the original geometry that may be associated with seismic stresses or long-term deformations.

*Figure 32* TLS technology and its application in heritage documentation (a) Principle of TLS. (b) A resultant point cloud of TLS survey. Source: MDPI
