Protection of Cultural Heritage and Monuments of Nature from the Effects of Climate  
Change (CCC)

The Archaeological Site of Delphi under the Threat of Climate Change:  
Documentation of Deterioration and Proposals for Conservation and Protection

Master Thesis

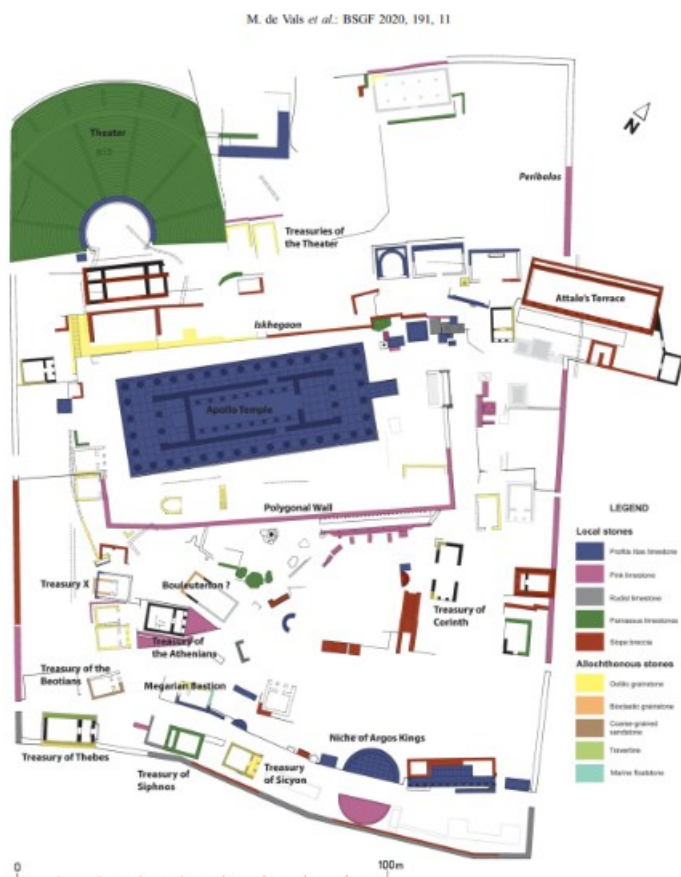
Figure 1. Lithological map of the Sanctuary of Apollo at Delphi, showing the spatial distribution of the principal stone materials used in the monuments of the archaeological site, including Prophet

*Elias limestone, Parnassus limestone, rudist limestone, and slope breccia formations (modified from de Vals et al., 2020).*

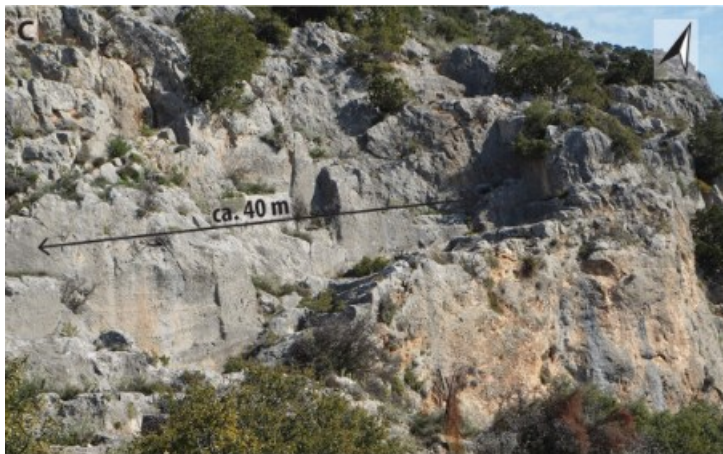
*Figure 2. The Stadium Quarry, located above the Ancient Stadium of Delphi which is considered one of the probable sources of the Parnassus limestone used in the construction of the monument (adapted from de Vals et al., 2020).*

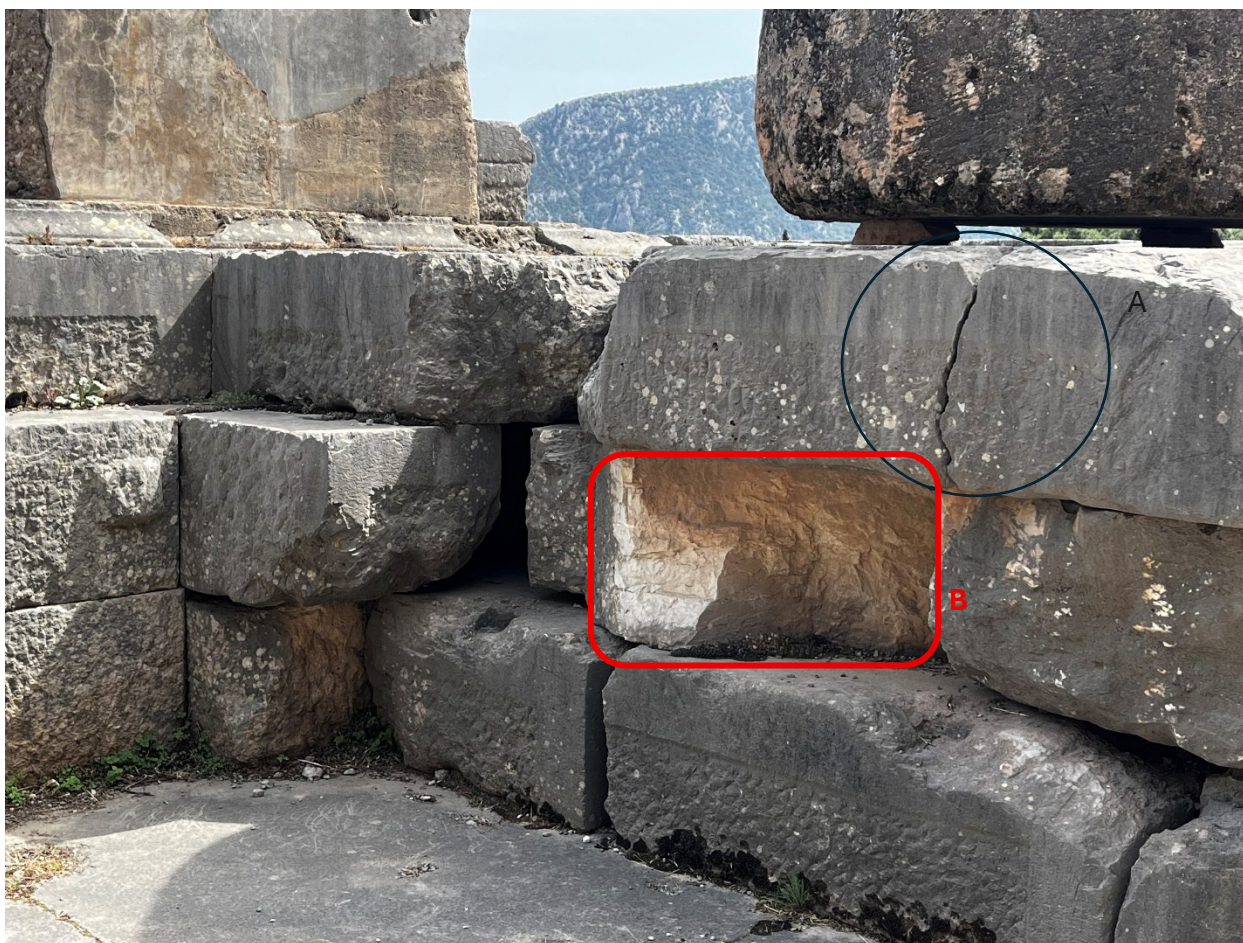
*Figure 4. Deterioration patterns observed on stone elements of the crepidoma of the Temple of Apollo: (A) fracture, classified under Crack and Deformation → Crack → Fracture, and (B) fragmentation, classified under Detachment → Fragmentation, according to the ICOMOS–ISCS (2008) terminology (author's photograph, 2026).*

In the photograph above, two different forms of deterioration can be identified. The area marked with the letter A is classified as a fracture, given that the discontinuity extends completely through the stone element, and according to ICOMOS–ISCS it belongs to the Crack and Deformation category. In contrast, area B is classified as fragmentation and belongs to the Detachment category. Consequently, although two forms of deterioration are identified in the same area of the monument, they do not represent the same form of deterioration.

expansion and contraction caused by pronounced daily and seasonal temperature fluctuations. These processes may contribute to the gradual widening of existing discontinuities and to the reduction of the mechanical integrity of the stone elements. Nevertheless, in the present study, the above factors can only be considered as possible contributors to mechanical deterioration, since the on-site macroscopic observation does not allow them to be identified as the specific causes of the fracture and fragmentation documented in Figure 4.

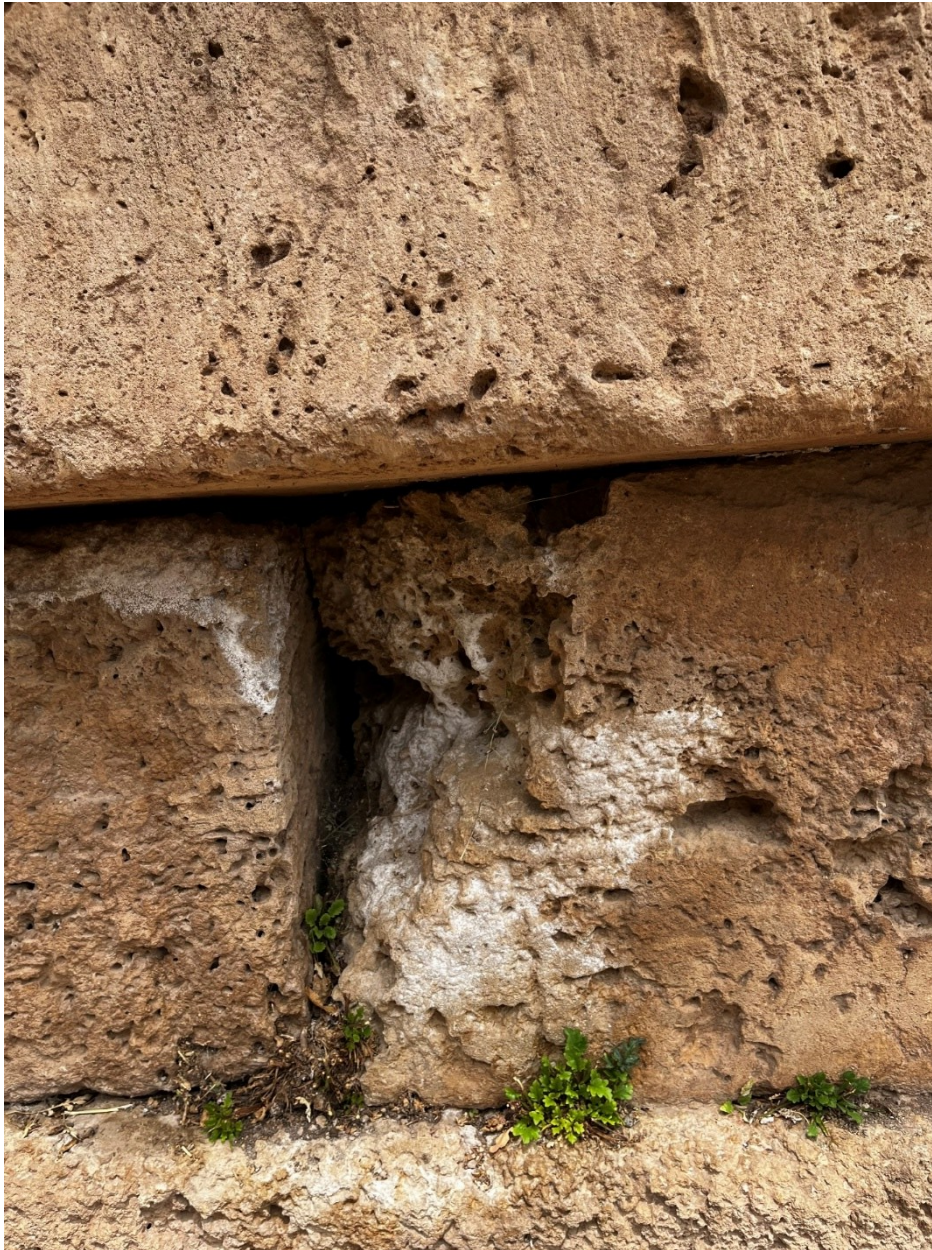
*Figure 6. Localised weathering and material loss on a stone element of the Temple of Apollo. The photograph illustrates the development of a porous surface texture and the deterioration of the stone's superficial layer.*

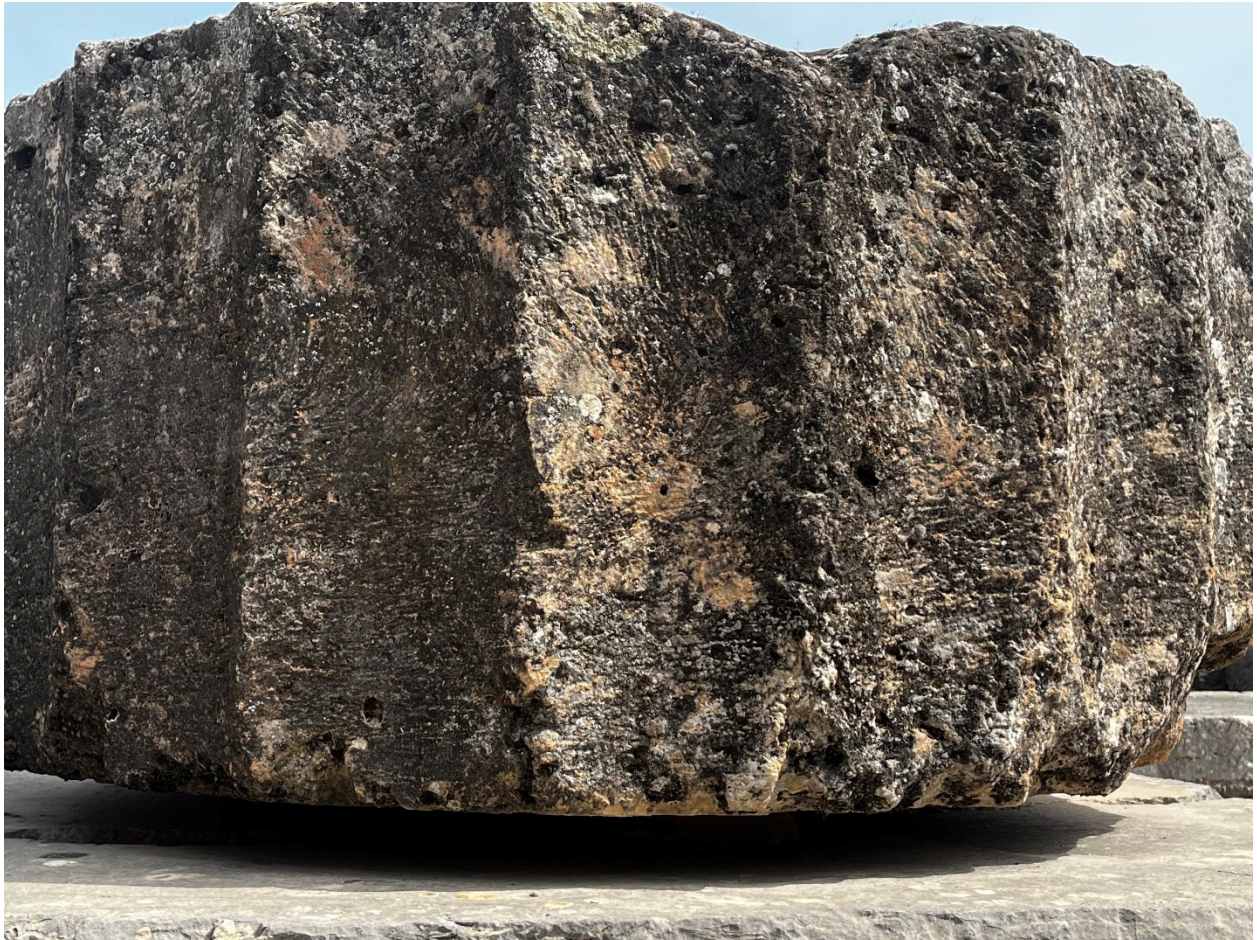
*Figure 7. Deterioration patterns observed on a column drum of the Temple of Apollo, including alveolarization, rounding of the stone edges, and biological colonization, identified macroscopically according to the ICOMOS-ISCS (2008) terminology (author's photograph, 2026).*

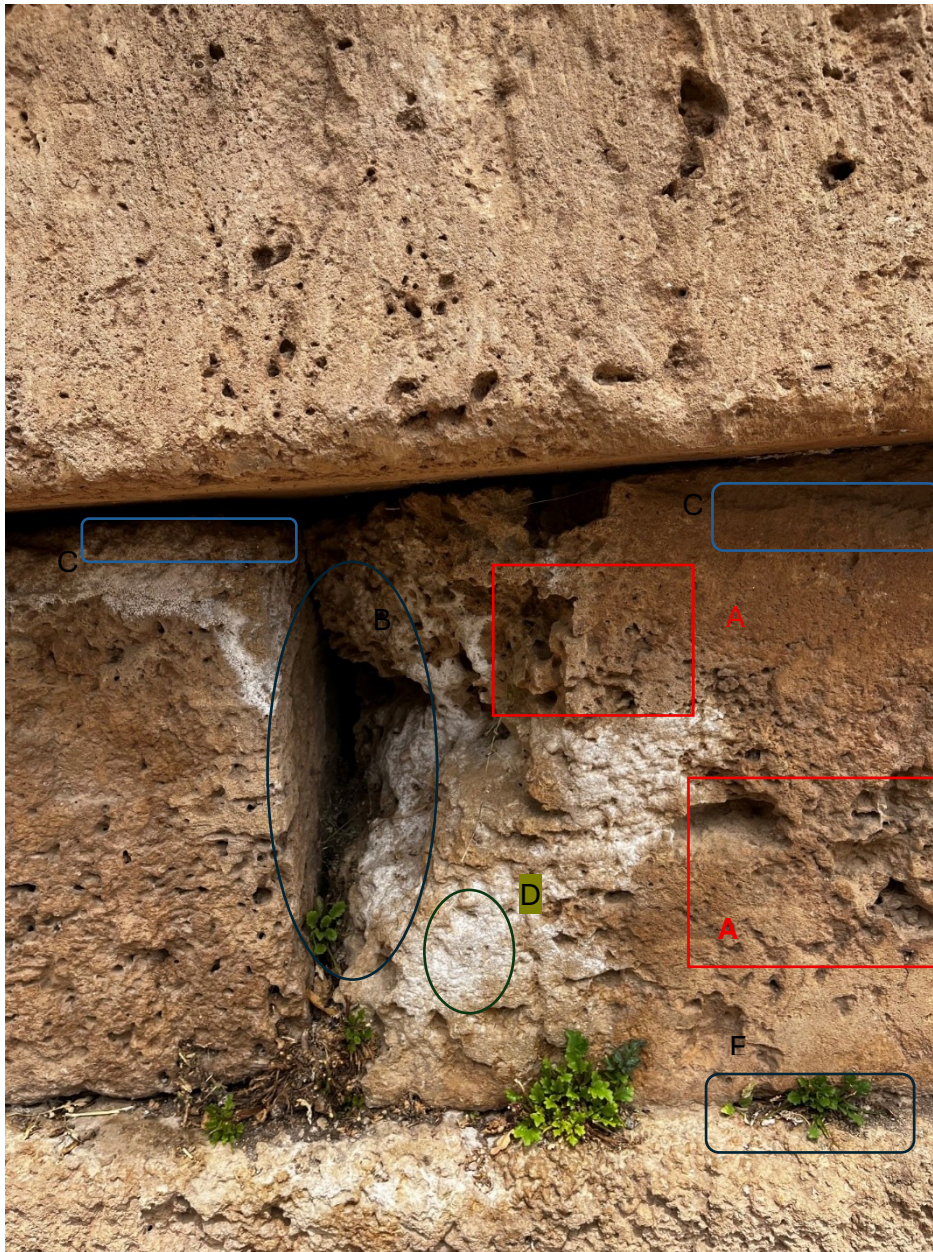
Figure 8. Deterioration patterns observed on a stone element of the Temple of Apollo: (A) alveolar weathering, (B) material loss and surface recession, (C) differential erosion and rounding, (D) white surface deposits possibly associated with salts, and (E) higher plant growth, identified macroscopically according to the ICOMOS–ISCS (2008) terminology (author’s photograph, 2026).

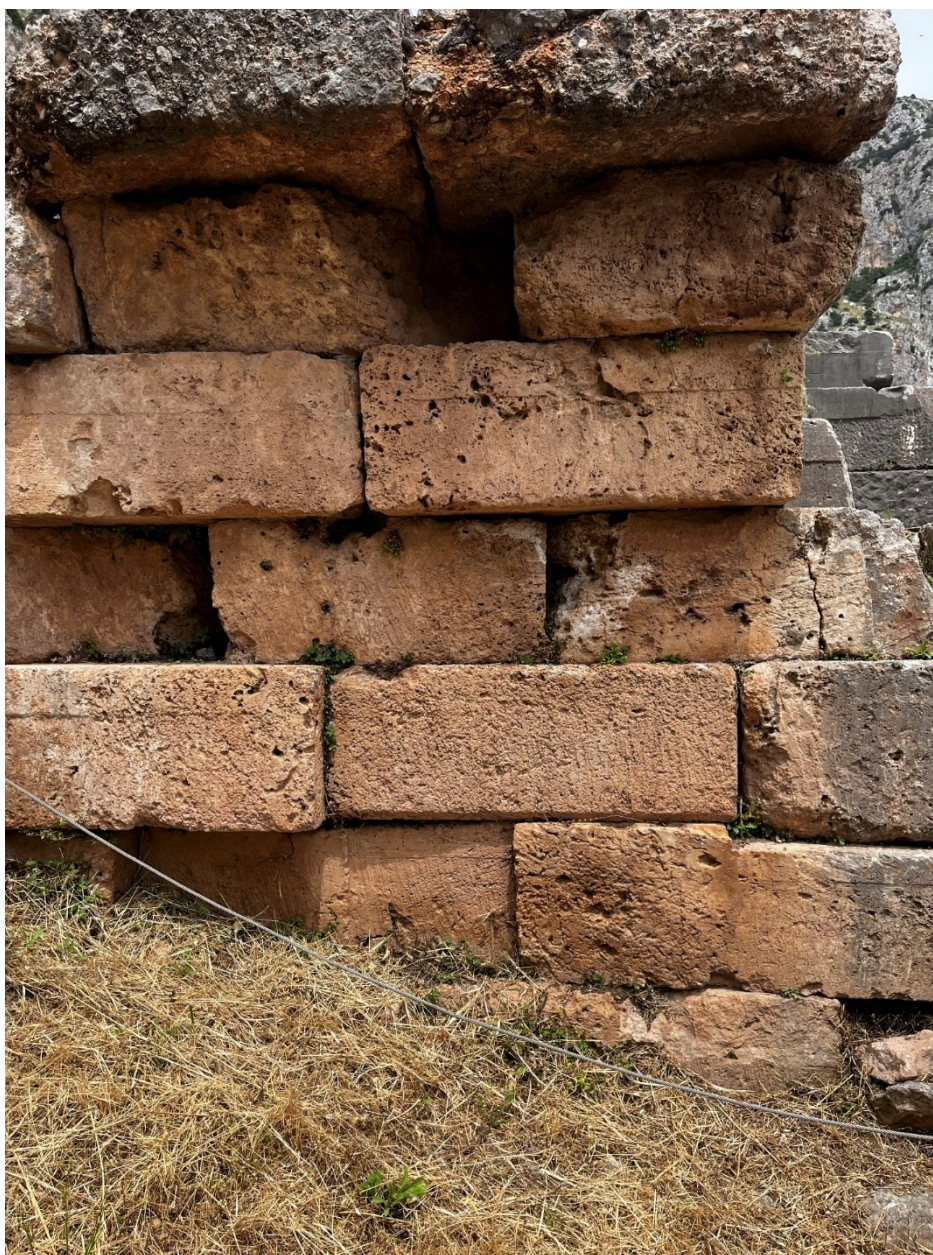
*Figure 9 Surface recession, alveolarization, and biological colonization with higher plant growth observed on stone elements of the Temple of Apollo, identified macroscopically according to the ICOMOS-ISCS (2008) terminology (author's photograph, 2026).*

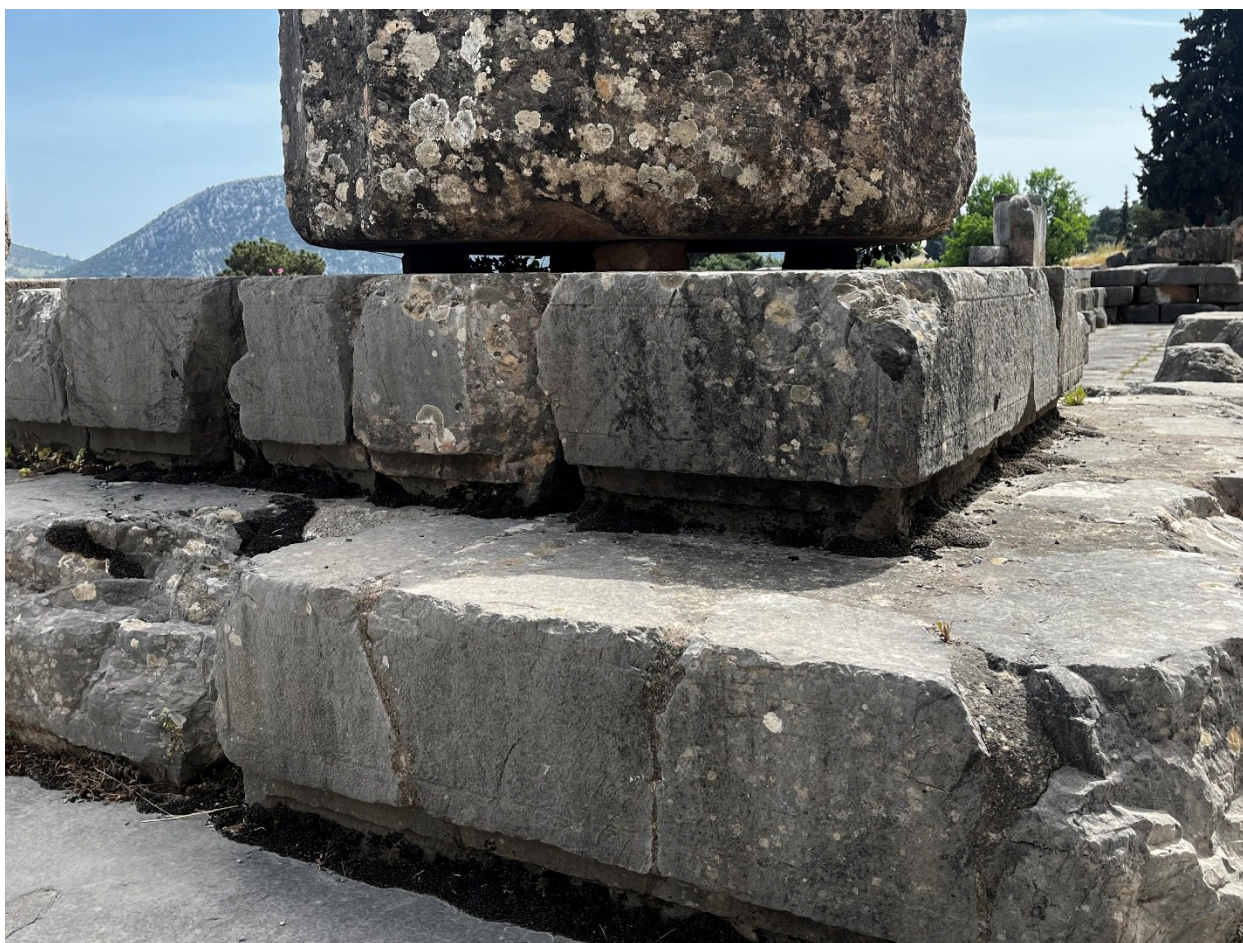
*Figure 10. In addition to biological colonization, other deterioration patterns can also be observed on the stone elements, including cracks and localised material loss. Their coexistence within the same architectural area further illustrates that different forms of deterioration may occur simultaneously on the monument.*

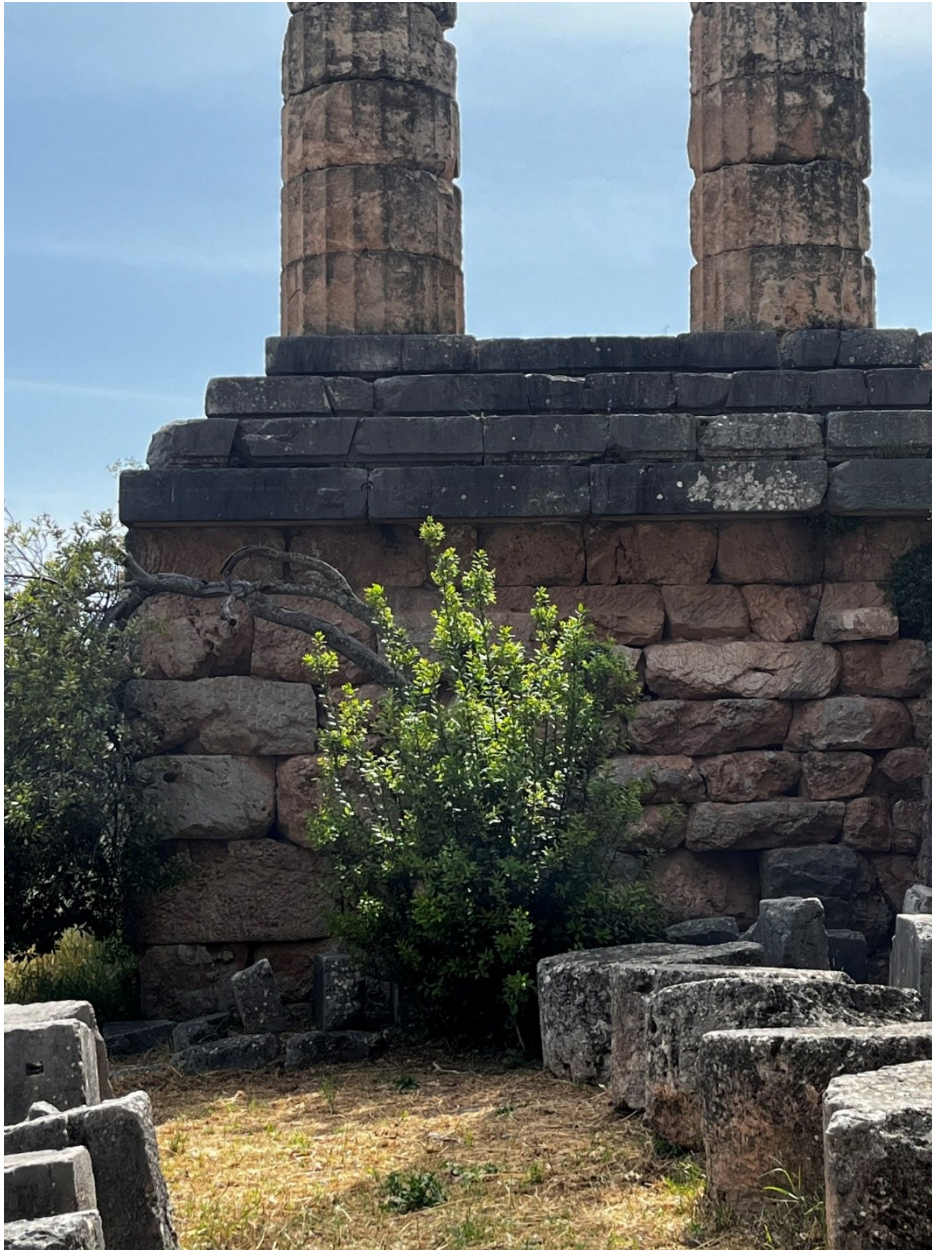
*Figure 11. Shrub vegetation growing in close proximity to the structural elements of the Temple of Apollo. (author's photograph, 2026)*

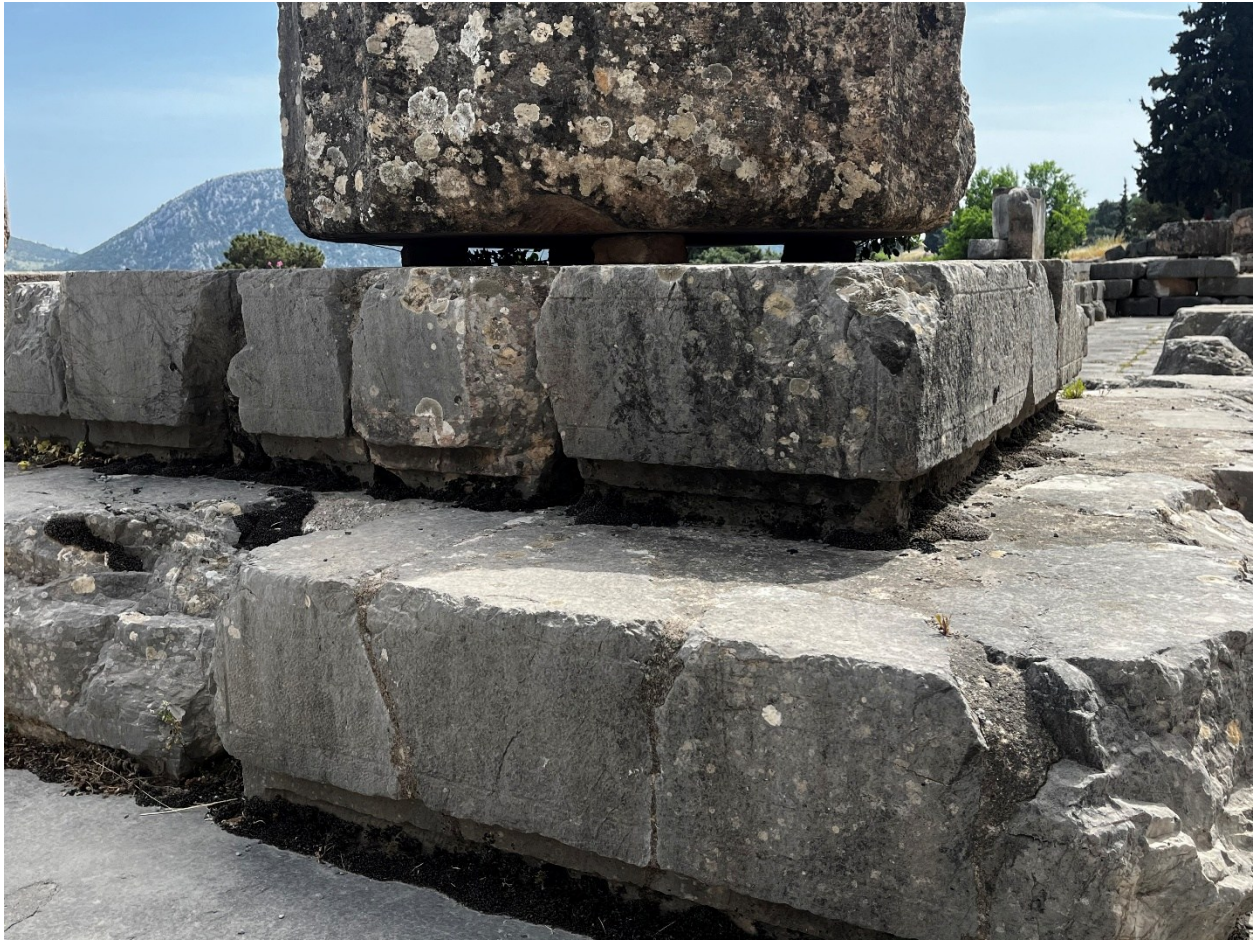
*Figure 12. Lichen colonisation and biological surface deposits observed on an architectural element of the Temple of Apollo.*

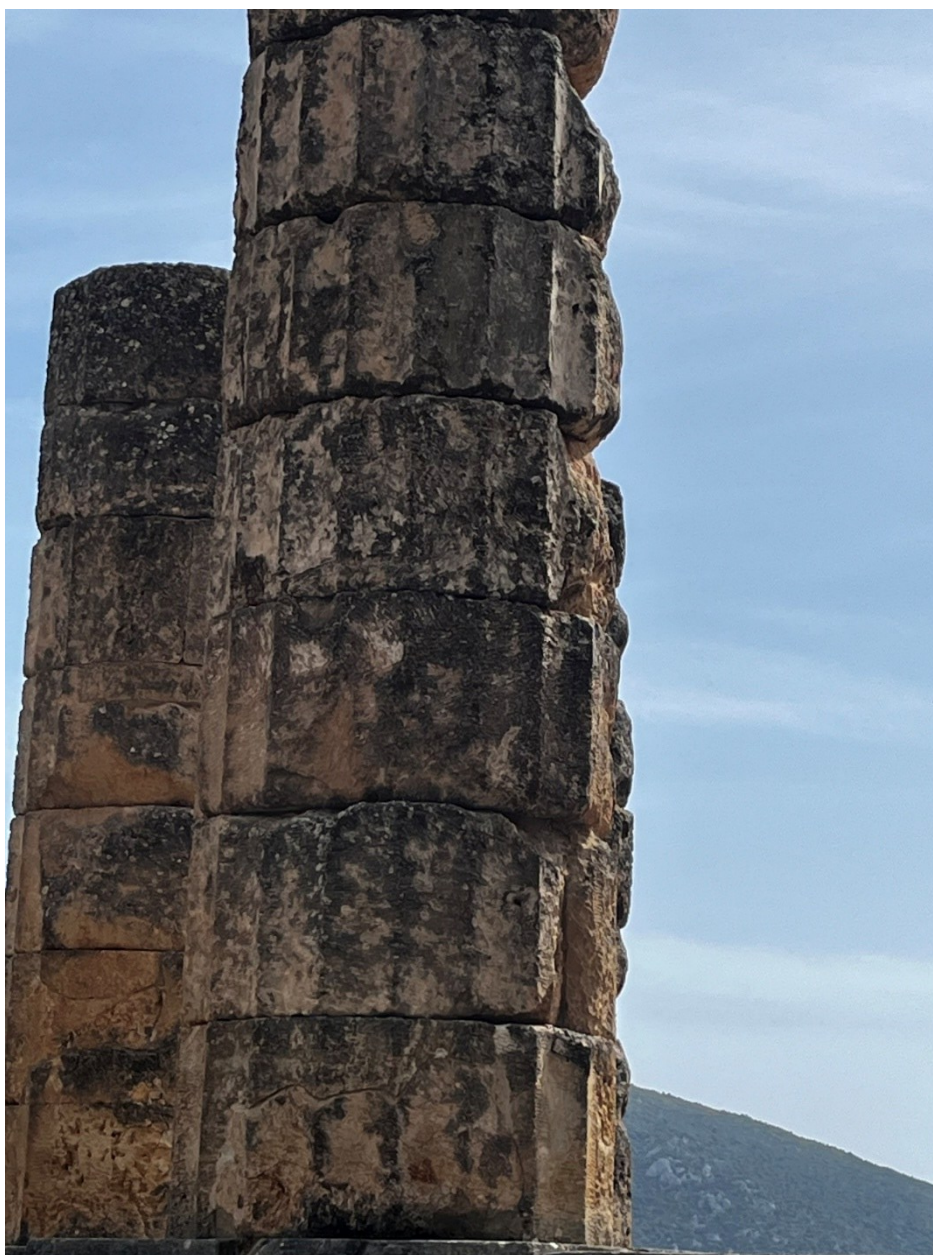
*Figure 13. General view of discoloration and surface deposits on stone elements of the Temple of Apollo, with visible cracks, discontinuities and rounding of stone edges (author's photograph, 2026).*

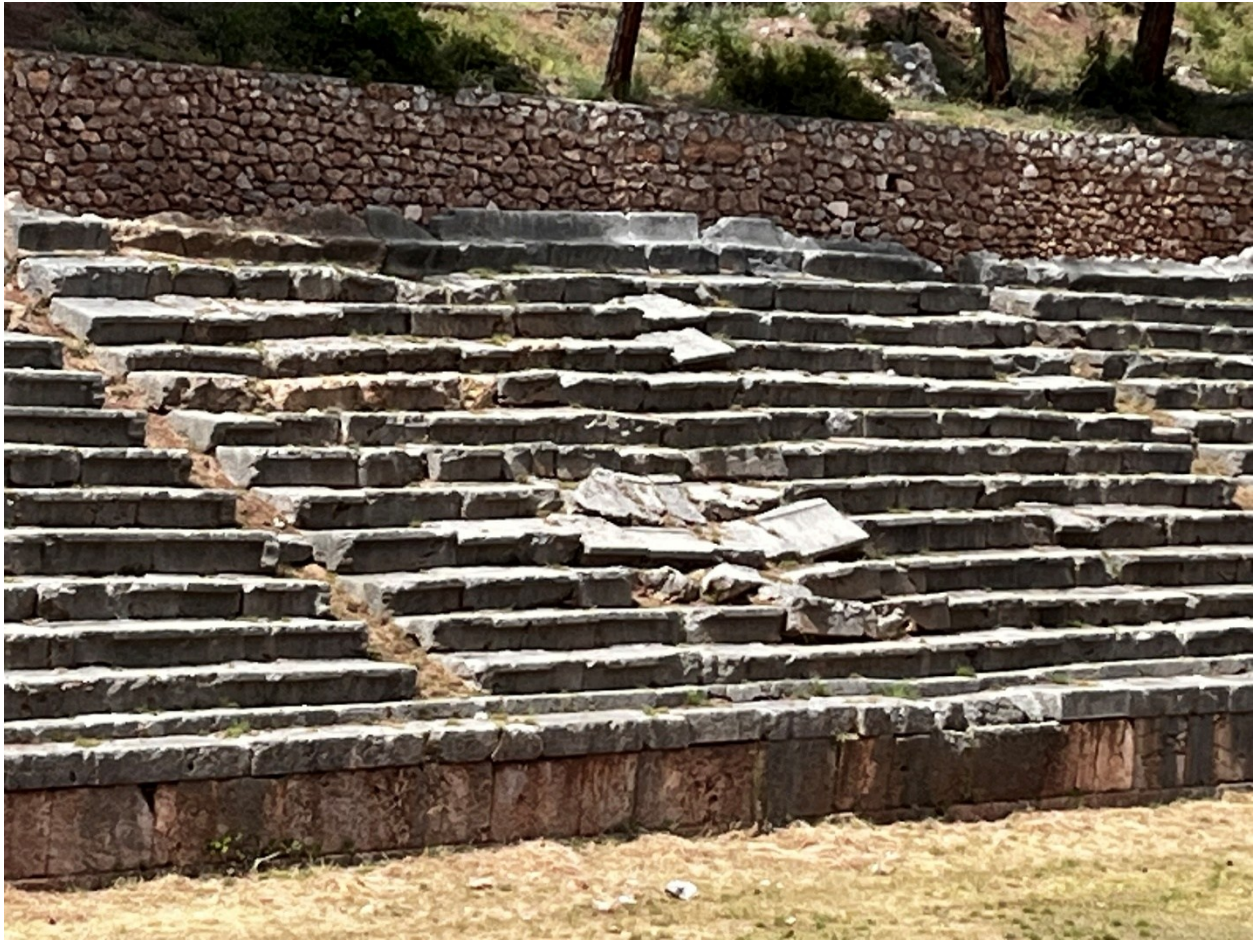
*Figure 16. Extensive disorganisation and localised displacement of stone elements in the seating tiers of the Ancient Stadium of Delphi, with detached stone fragments present in the central area. These observations document the macroscopic condition of the seating tiers, while visual examination alone does not allow the mechanisms or factors that led to the observed condition to be determined (author's photograph, 2026).*

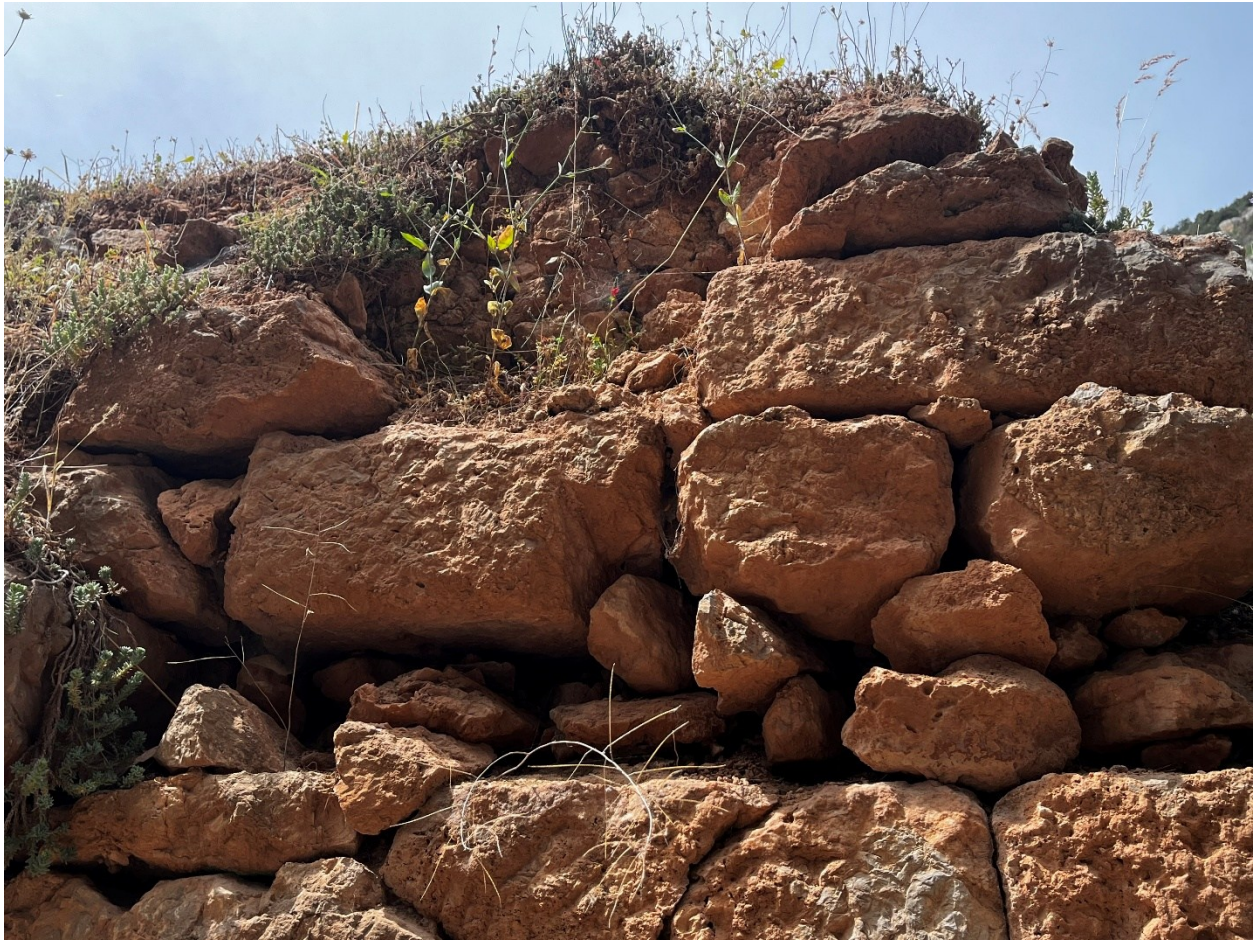
*Figure 17. Stone elements and vegetation on the slope in the area of the Ancient Stadium of Delphi. The localised removal of loose soil material may be associated with surface runoff and washing by water, although this mechanism cannot be confirmed through visual observation alone. The presence of plants is recorded as biological colonisation (plant), according to the ICOMOS–ISCS (2008) terminology (author’s photograph, 2026).*

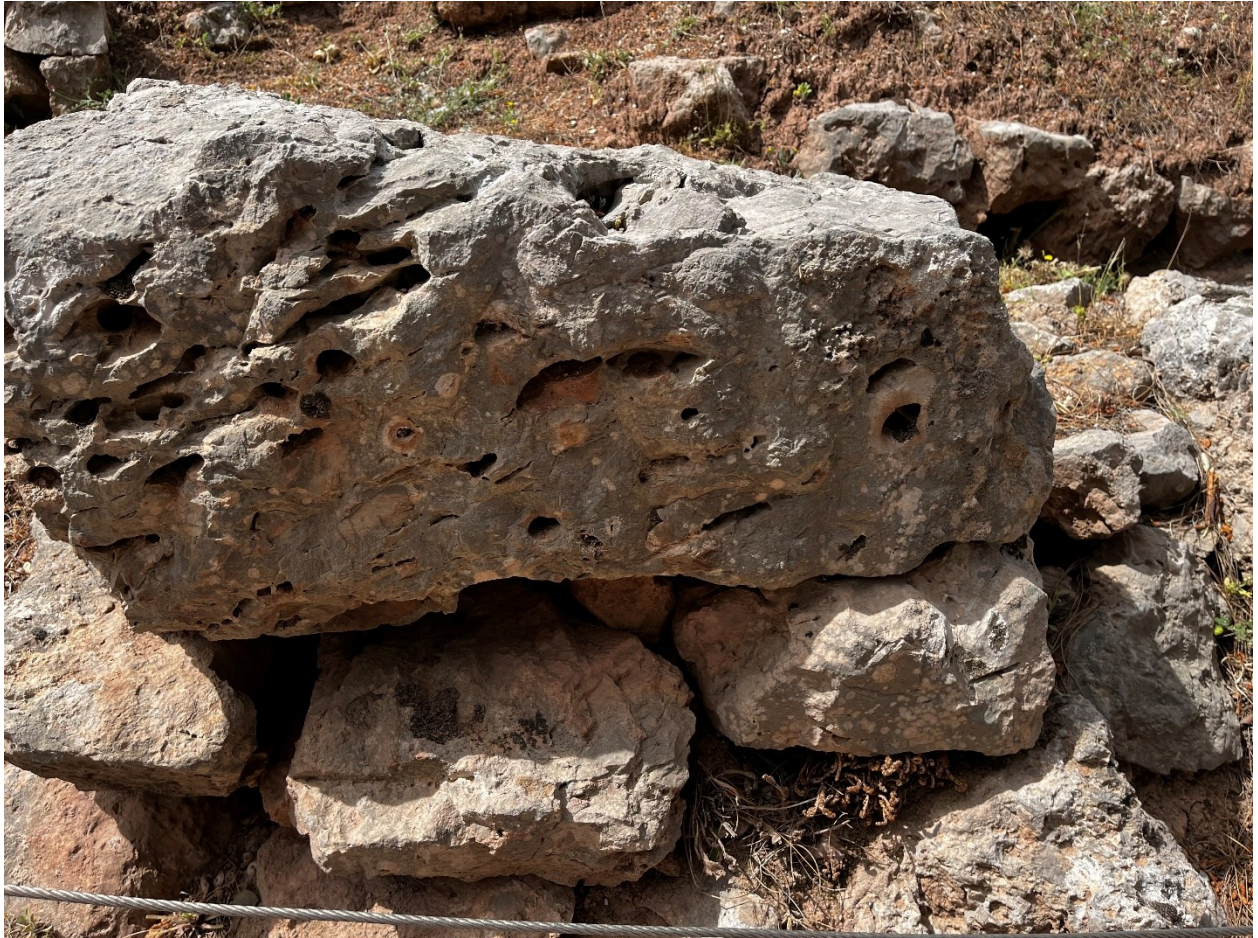
*Figure 19. Pronounced alveolization in a stone element in the area of the Ancient Stadium of Delphi, characterized by the development of multiple cavities and localised material loss on the stone surface. The deterioration pattern was identified macroscopically according to the ICOMOS–ISCS (2008) terminology, (author’s photograph, 2026).*

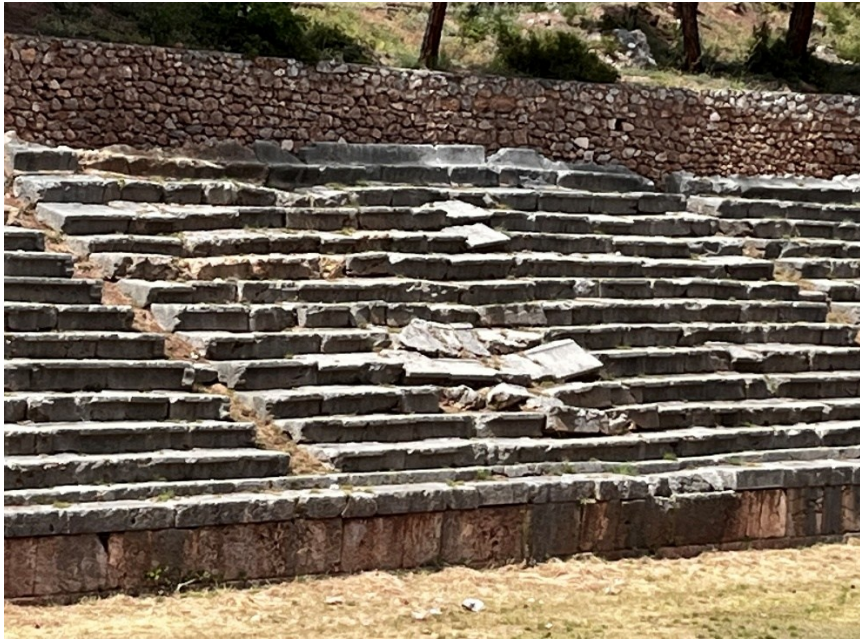
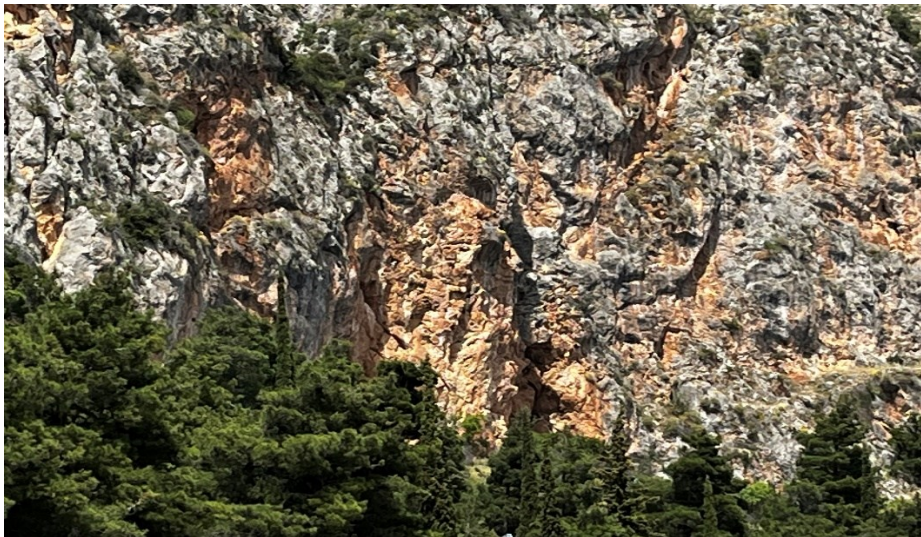
*Figures 20 and 21. Macroscopic condition of the stone seating tiers of the Ancient Stadium of Delphi (top) and view of the steep limestone slopes of the Phaedriades overlooking the archaeological site (bottom). The two images illustrate the location of the monument in relation to its immediate geomorphological setting. The proximity of the steep rocky slopes represents an important parameter of the Stadium's exposure conditions, particularly in relation to the geodynamic instability and rockfalls documented in the area (author's photographs, 2026).*

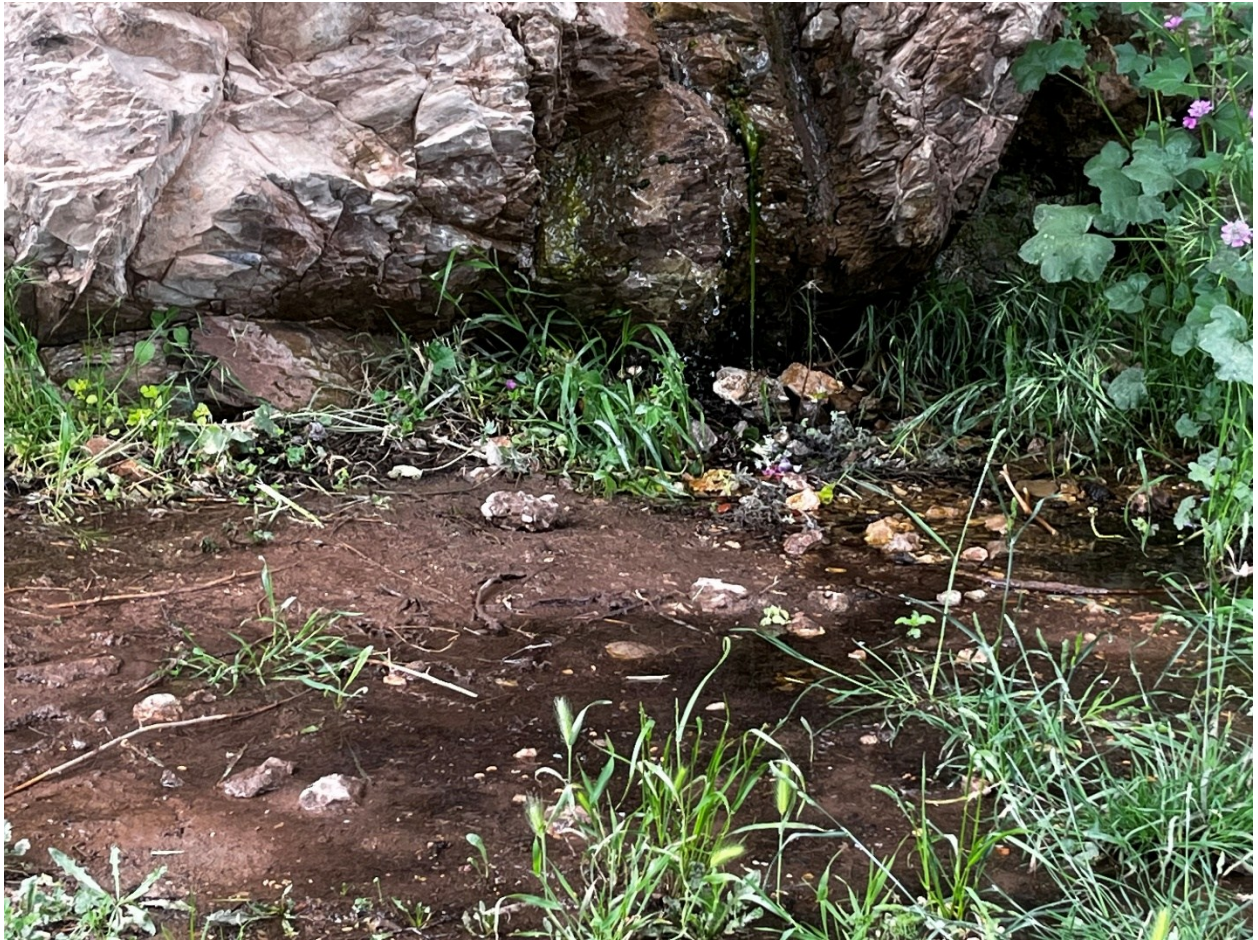
*Figure 22. Presence of surface water runoff in the area of the Ancient Stadium of Delphi. The observation documents the presence of water and local runoff pathways in the immediate environment of the monument, which form part of its exposure conditions (author's photograph, 2026).*

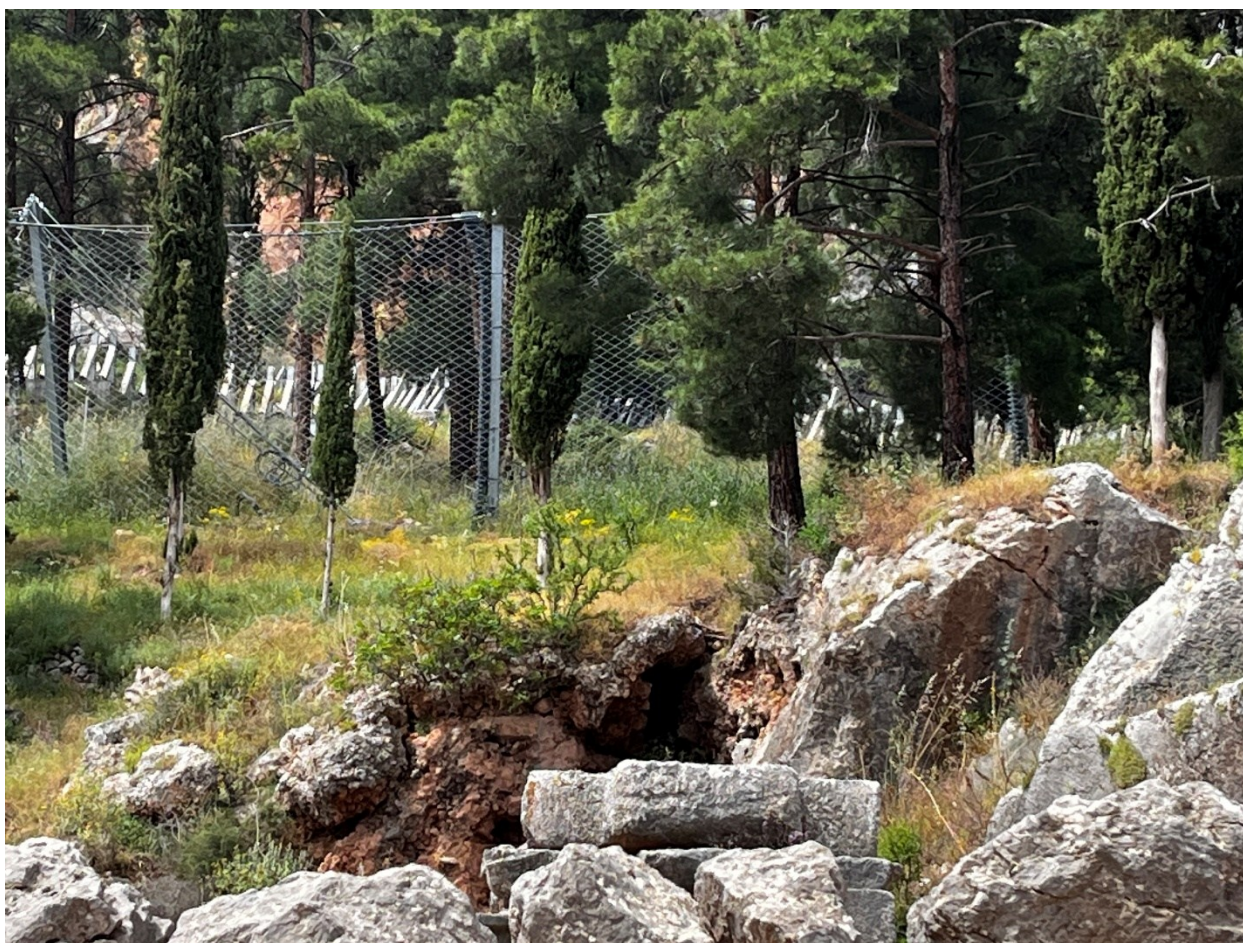
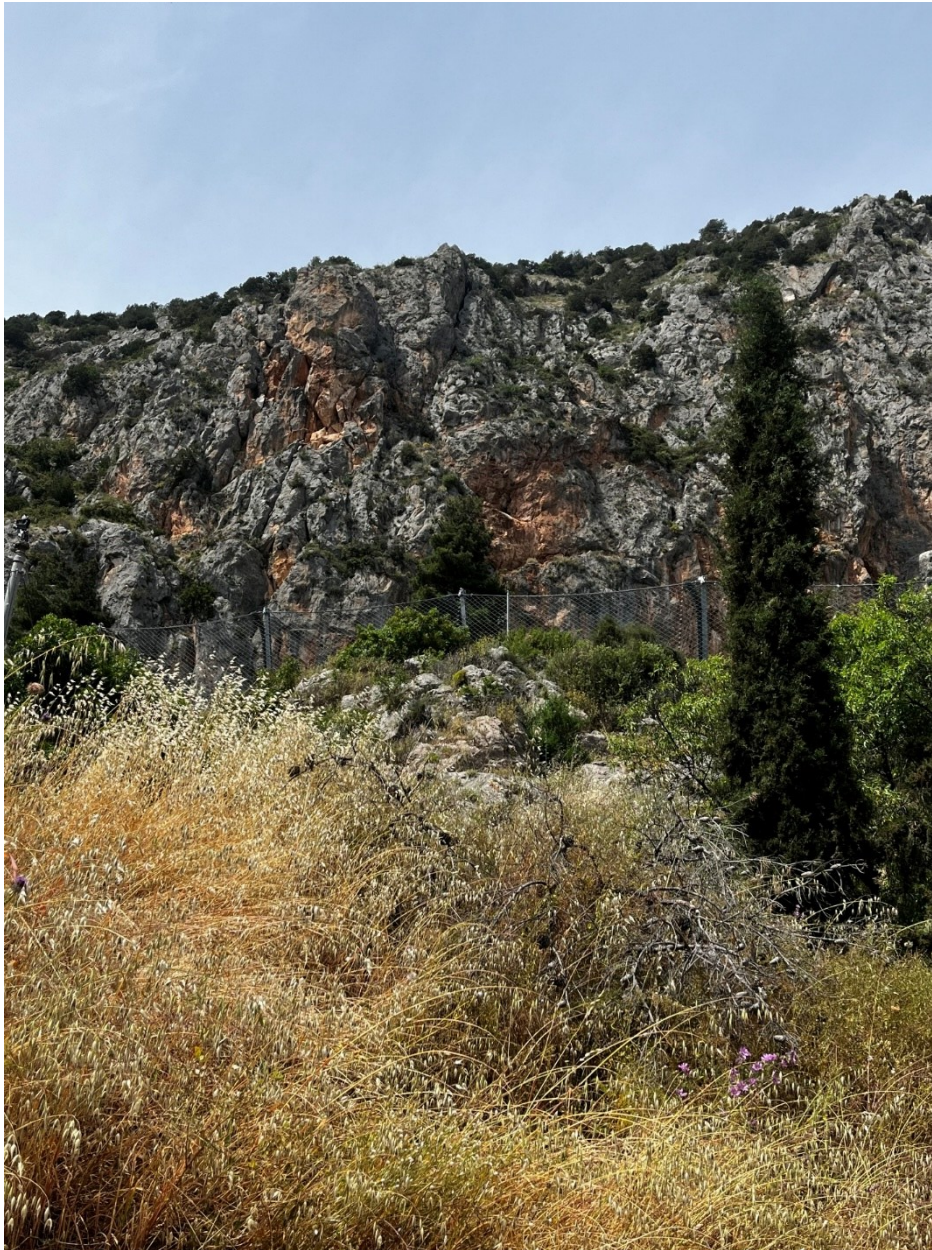
*Figures 23 and 24. Rockfall protection measures in the area of the Ancient Stadium of Delphi (top) and view of the steep limestone slopes of the Phaedriades (bottom). The protective systems and the morphology of the rocky slopes document the geomorphological setting in which the monument is located. Rockfalls and slope instability represent important parameters of the exposure conditions of the area and have been documented in the literature for the archaeological site of Delphi (author's photographs, 2026).*
